Transport
for NSW

Oxley Highway

Route Safety Review

July 2015

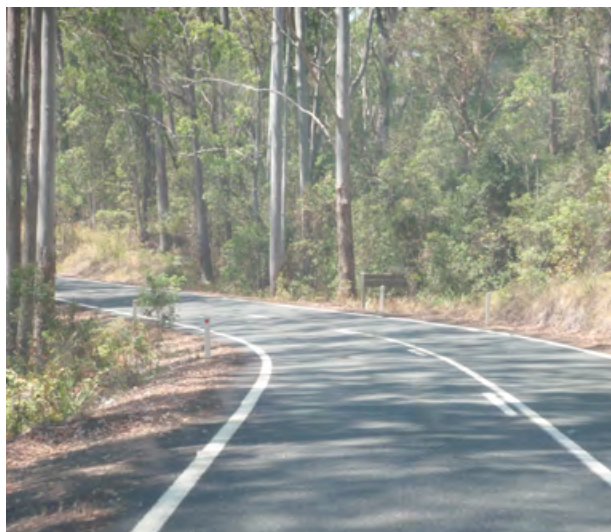
- Some submissions raised the issue of sections of centreline marking that allowed overtaking when forward sight distance was inadequate.

Photograph 1.7: Centreline marking permitting overtaking around curve

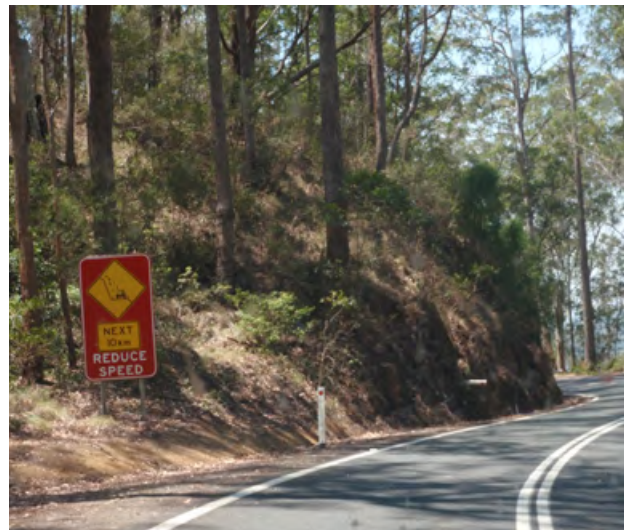
- Many submissions discussed the need for stronger maintenance regimes to address pavement failures.
- There were many submissions concerned about the amount of loose material on the pavement, especially on the eastern escarpment. This was a particular concern for motorcyclists.

Photograph 1.8: Loose material often falls onto the pavement through the eastern escarpment

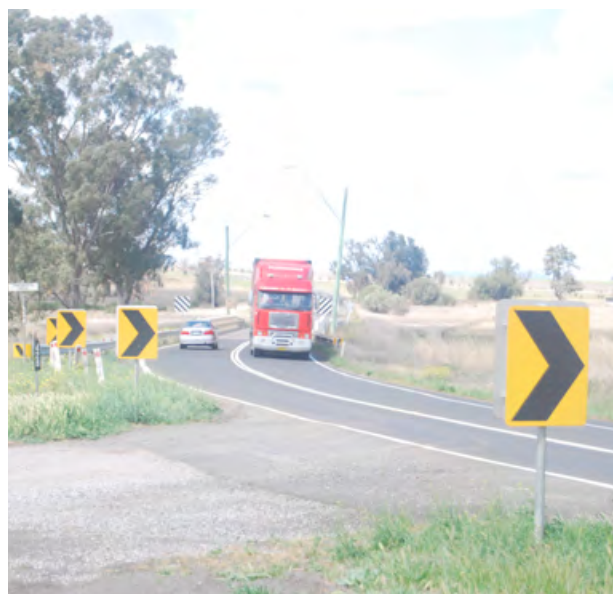
Photograph 2.3: Tangaratta Creek Bridge west of Tamworth

- A number of narrow bridges often had low radius curves on one or both approaches. One particular bridge, over Tangaratta Creek west of Tamworth, is the site of a number of casualty crashes including two fatal crashes.
- Many older bridges have little or no shoulders and reduced lane widths.
- There is a lack of consistent advance warning to motorists of the existence of narrow bridges.
- The older concrete abutments and bridge rails were difficult to distinguish, especially at night with little or no delineation.

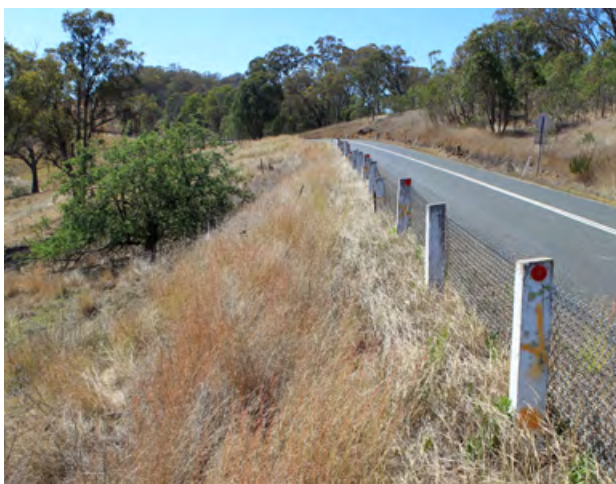
- Some sections of safety barriers had unsealed or neglected shoulders to the edge lines.
- Sections of wire rope safety barriers with green upright supports tended to blend in with the background and therefore lacked adequate delineation.

Photograph 2.5: Chain wire barrier west of Walcha

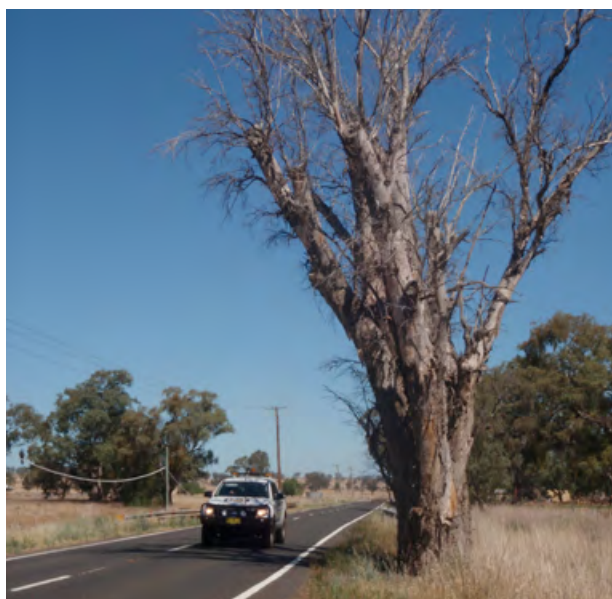
- Clear zones along the entire length of the highway need to be more closely examined. There were a number of significant unprotected culverts and trees very close to the edgeline.
- In a number of locations west of Tamworth and west of Gunnedah there were large dead trees well within the clear zone.
- There are many clear zone issues through the eastern escarpment between Long Flat and Yarrowitch. Many of these are exacerbated by narrow lane widths, little or no shoulders and steep embankments and drop-offs either side of the road.
- Long lengths of well established tree corridors are common within the road reserve generally in the western areas of the Oxley Highway. Many of these trees are large and growing within 3-4 metres of the edgeline.

Photograph 2.6: A dead tree well within the clear zone west of Tamworth

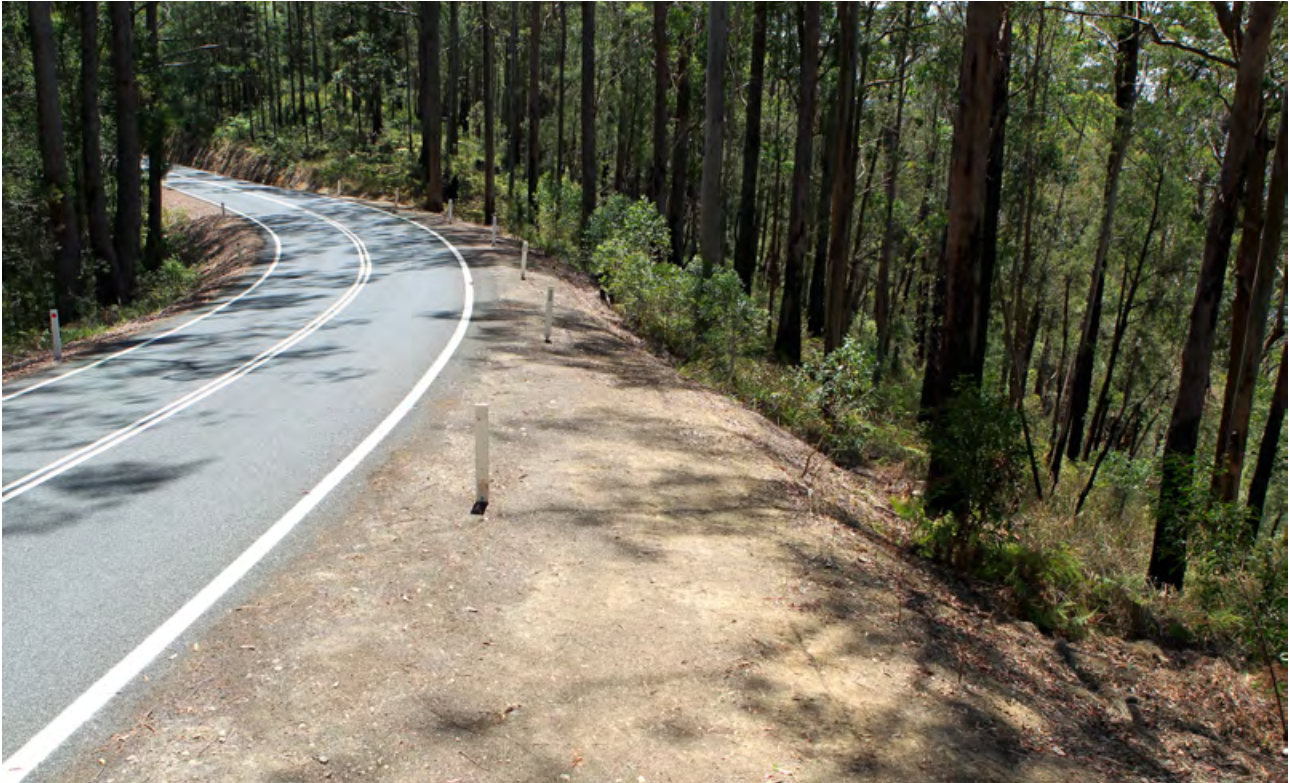
Photograph 2.7: Steep drop-offs and trees within the clear zone along the eastern escarpment

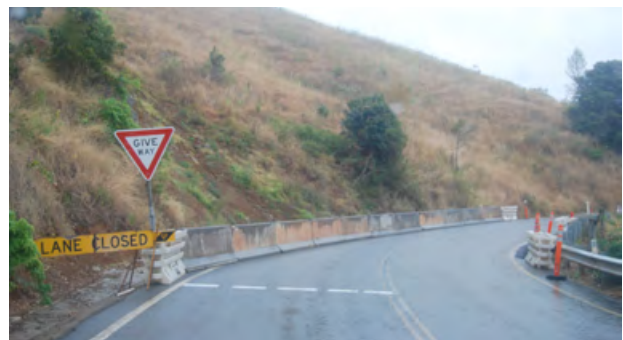
- The road pavement was generally in good condition. However, there were a few locations, mainly on the eastern escarpment where land slippages had affected the pavement condition.
- A short length of the highway between Walcha Road and the New England Highway has a very poor pavement with no sealed shoulders. This length of highway is to be rehabilitated during 2014.

Photograph 2.8: A partial road closure following a land slide on eastern escarpment

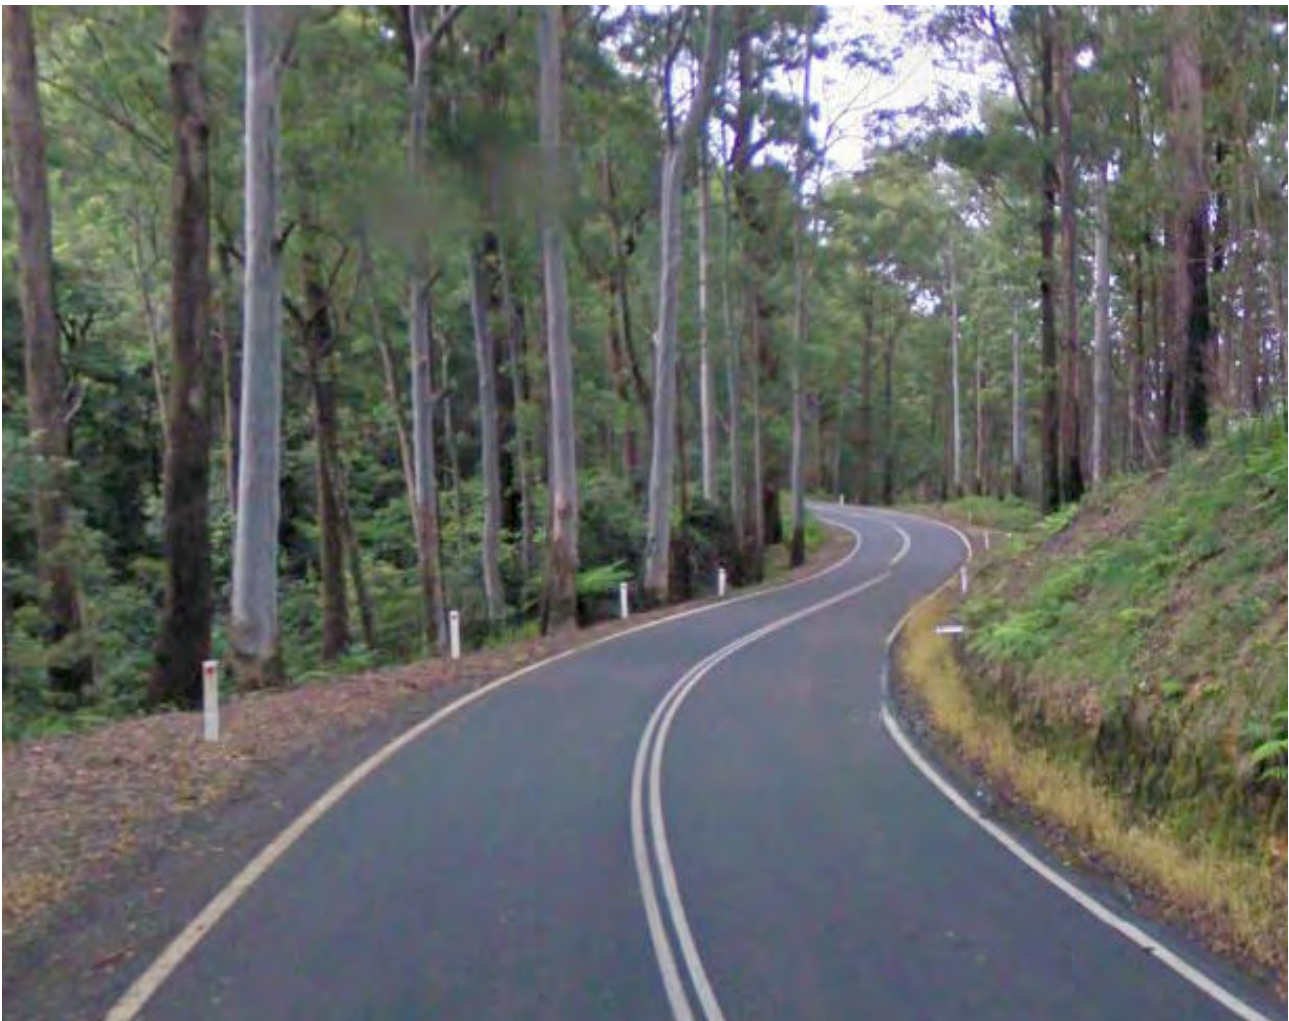
Objects within the clear zone are a potential hazard to the occupants and riders of errant vehicles. The Oxley Highway has a high proportion of casualty crashes involving hit object within the clear zone.

Photograph 3.2: Unprotected series of trees on the eastern escarpment

- Identification of locations, such as adjacent to trees, culverts, embankments and cuttings with narrow road shoulders, where a safety barrier is not currently provided.
- Where a hazard-free clear zone cannot be provided, the installation of safety barriers to protect road users from the adjacent hazard is an alternate measure.
- Where safety barriers cannot be installed it may be possible to widen and seal road shoulders to assist drivers and riders to regain control of their vehicles.
- Where these measures are not feasible due to the proximity of the hazard, consideration should be given to removing the hazard if possible.

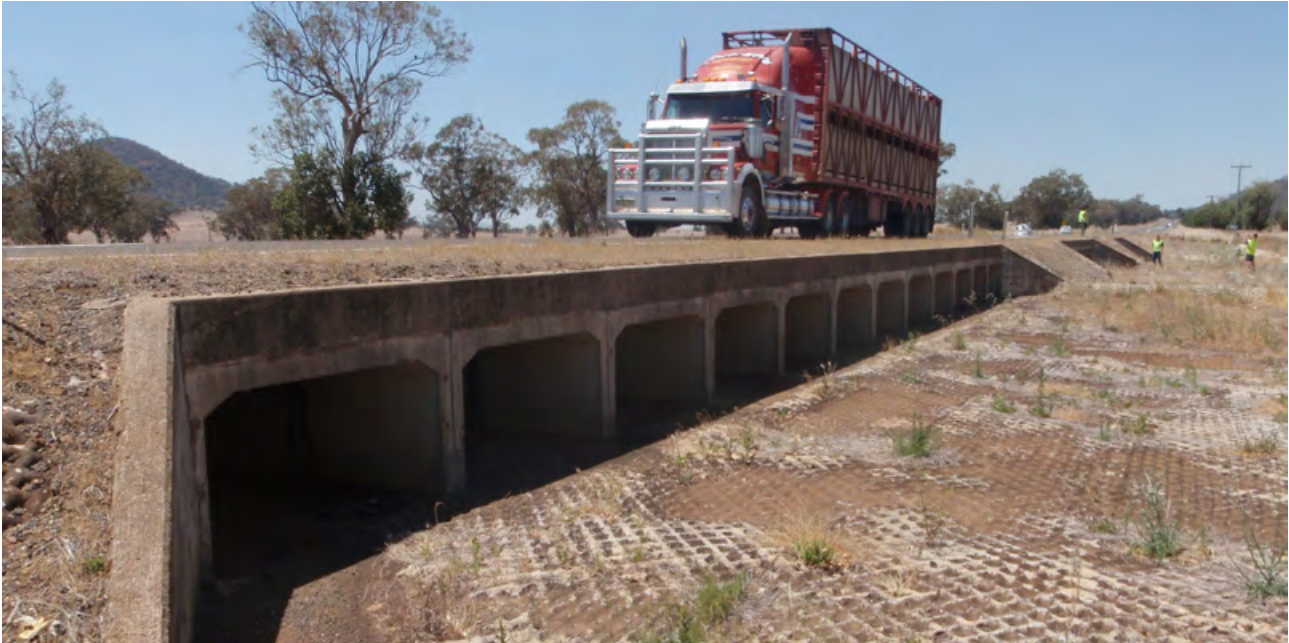
Photograph 3.3: Unprotected series of large culverts west of Gunnedah

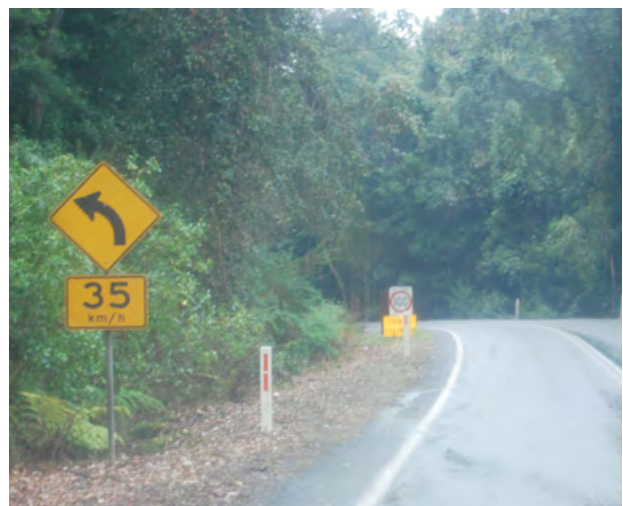
- A 100km/h speed limit on an extremely winding and narrow part of the highway over the entire length of the eastern escarpment. This length of highway also had a corresponding high casualty crash rate.
- The Safe System approach maintains that travel speeds as well as roads and roadsides should be designed and managed to reduce the risk of crashes and prevent serious injury or death to people in the event of a crash.
- An isolated 110km/h speed limit over a section of the highway east of Walcha with road safety deficiencies including lack of road shoulders, deep unprotected culverts and drop-offs and substandard junction treatments and substandard safety barriers.

Photograph 3.4: Very winding alignment on the eastern escarpment with high speed limit

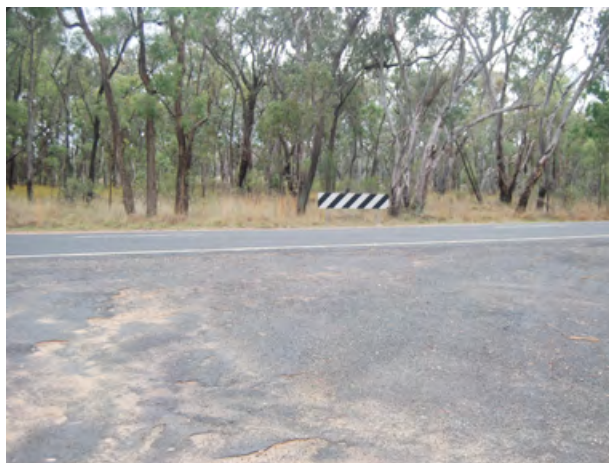
- The appropriateness of their design, especially those junctions with higher turning movements, signposted tourist attractions or restricted sight distances.
- The need to provide a short length of seal (for a distance of 5-10m back from the junction) on some gravel side roads.
- Adequate sight distance to and from the side road.
- The possibility of upgrading auxiliary right turn treatments to modified painted right turn bays.
- The possibility of providing vehicle actuated signposting, in advance of road junctions, where heavy vehicle usage increases significantly during certain seasons.
- The need for advance road name signposting, especially in high speed areas or where heavy vehicle or tourist traffic (particularly caravans) is common.

Photograph 3.6: Some road junctions require upgrades

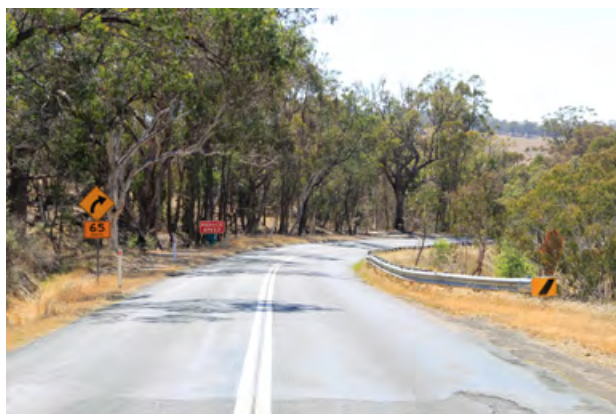
Photograph 3.8: Narrow pavement, no shoulders and tight curves east of the New England Highway
