**APPIN ROAD
KELLERMAN DRIVE TO PRINCES HIGHWAY**

ROAD SAFETY INVESTIGATION REPORT

MARCH 2014

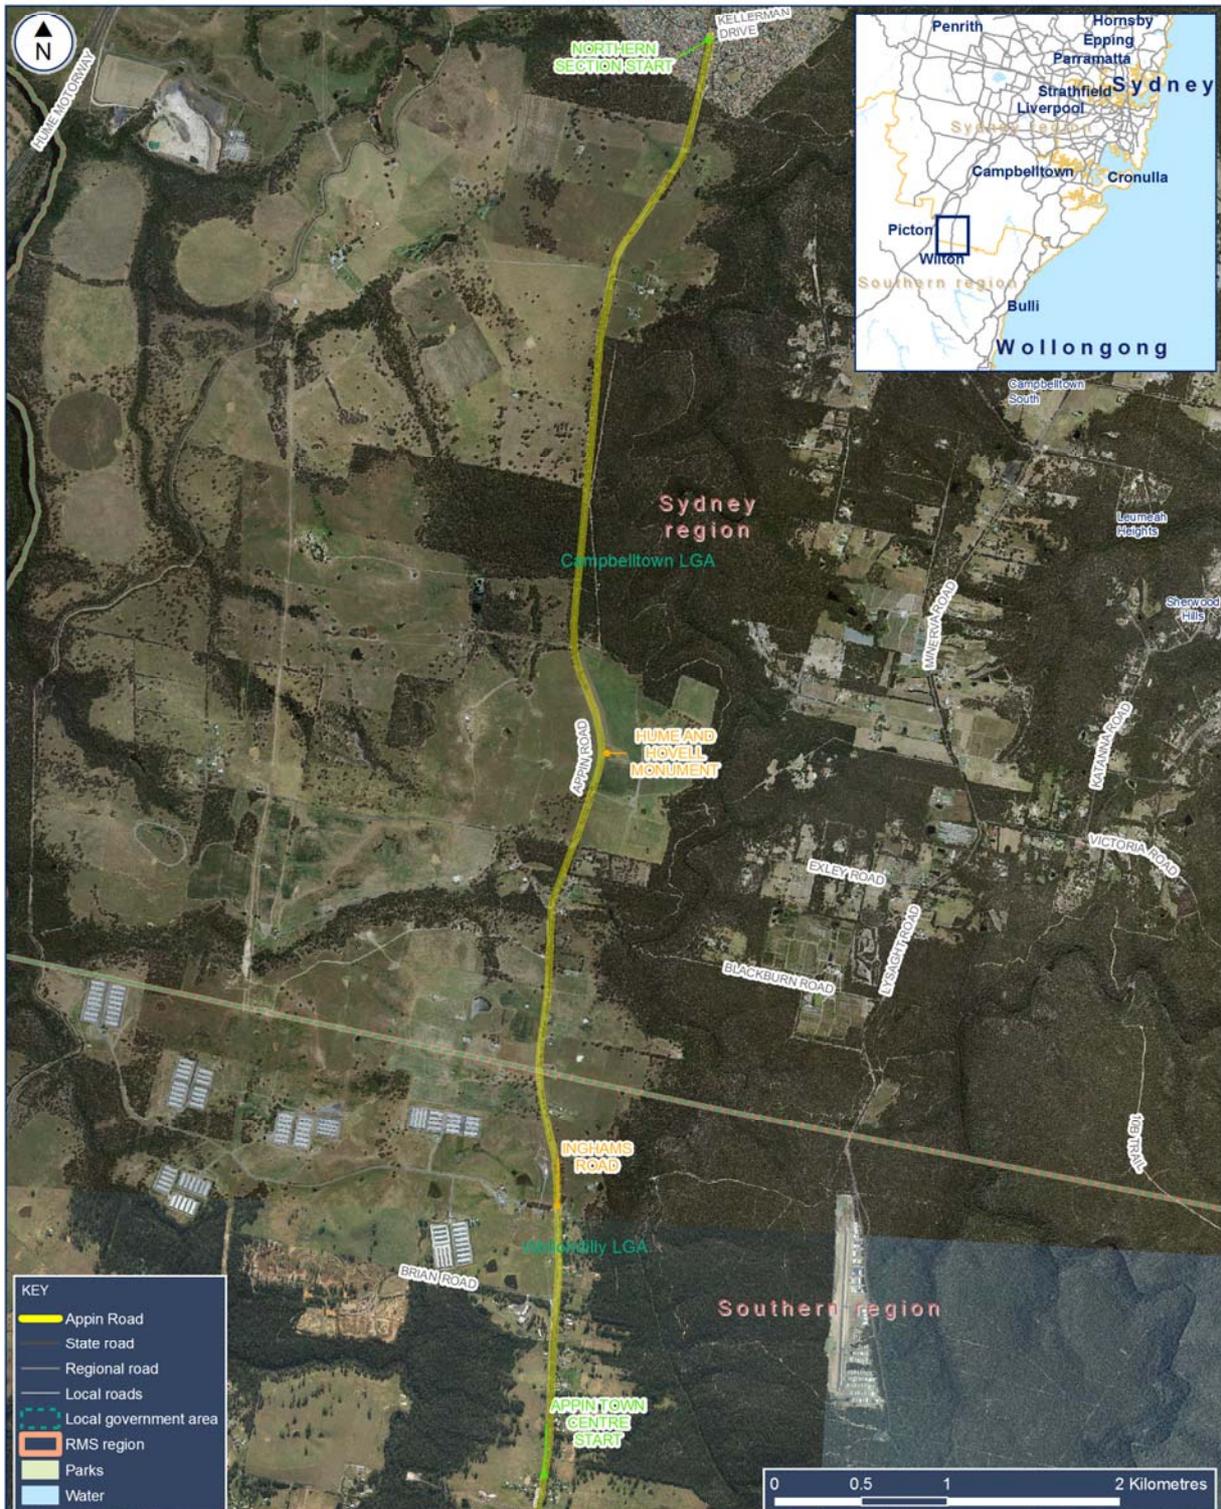
FIGURE 3. MAP OF SECTION 1 – APPIN ROAD NORTHERN SECTION

NORTHERN SECTION - Kellerman Drive to 315 m north of Rixon Road

Further analysis of the crash data for each section of Appin Road is shown in the following sections of this report. Figures 3, 4 and 5 show an overview of the three sections detailed below.

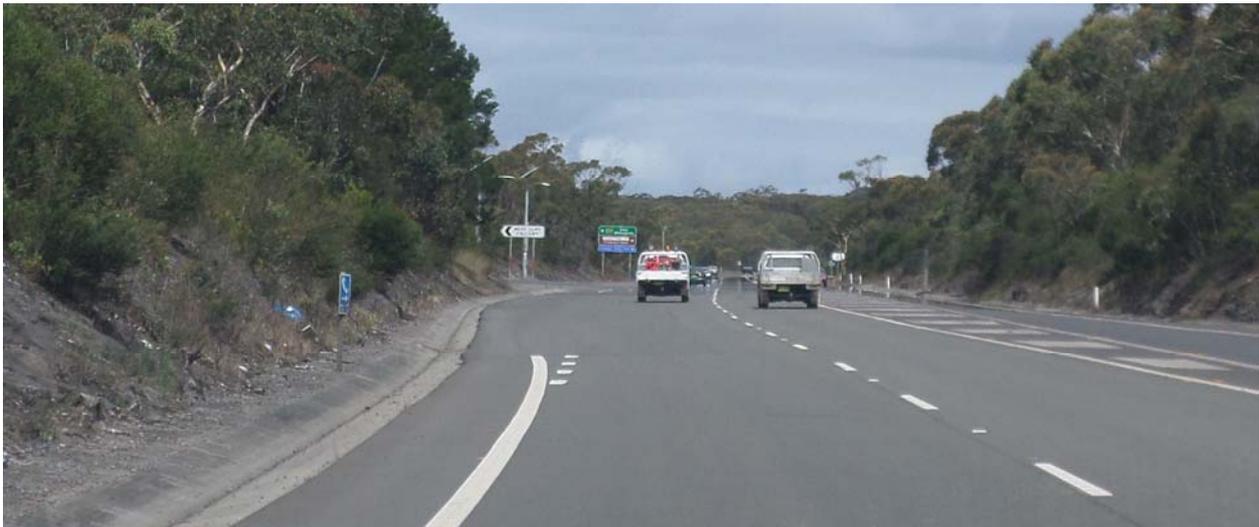
- Delineation along the length of Appin Road appears to be reasonable when viewed in daylight conditions, however there are a couple of sections where guideposts/reflectors appear to be missing and the profile edge and centre lines have not been replaced after heavy patching.

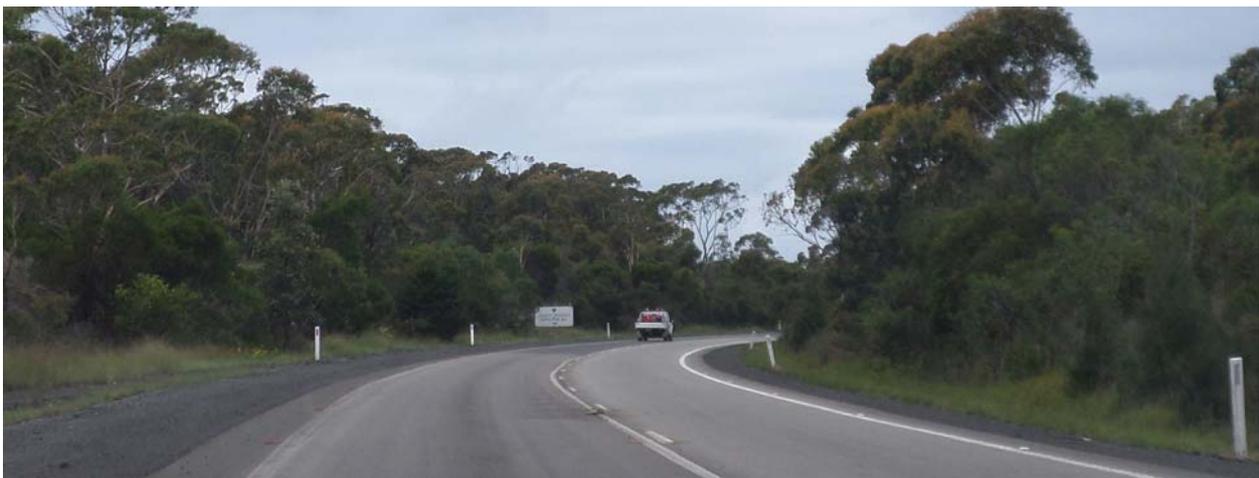
- Maintenance of vegetation along the length of Appin Road needs to be reviewed. There are a number of locations where vegetation on the inside of curves is limiting the sight distance available for road users.

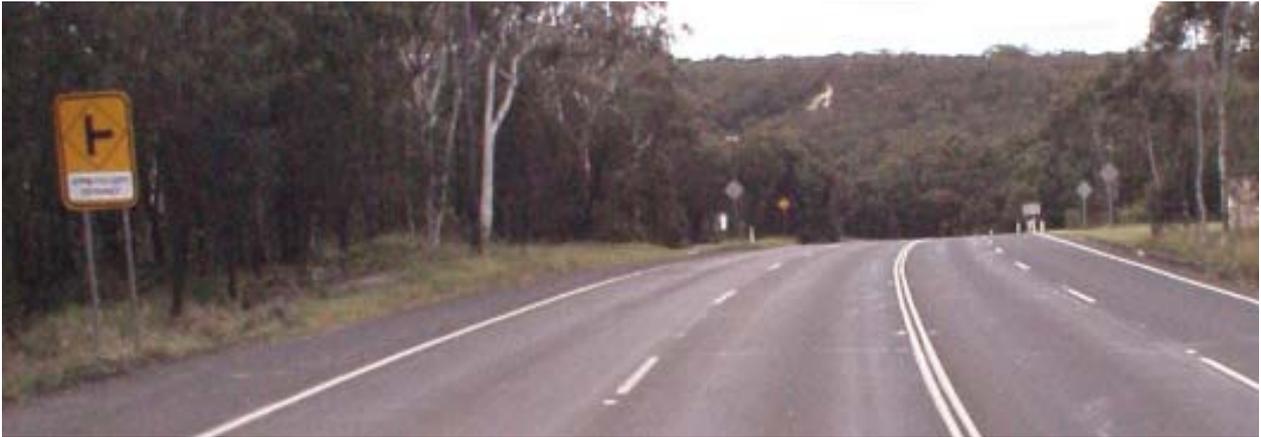
- The advance and intersection warning signage and road name signage is not consistently applied along the route.

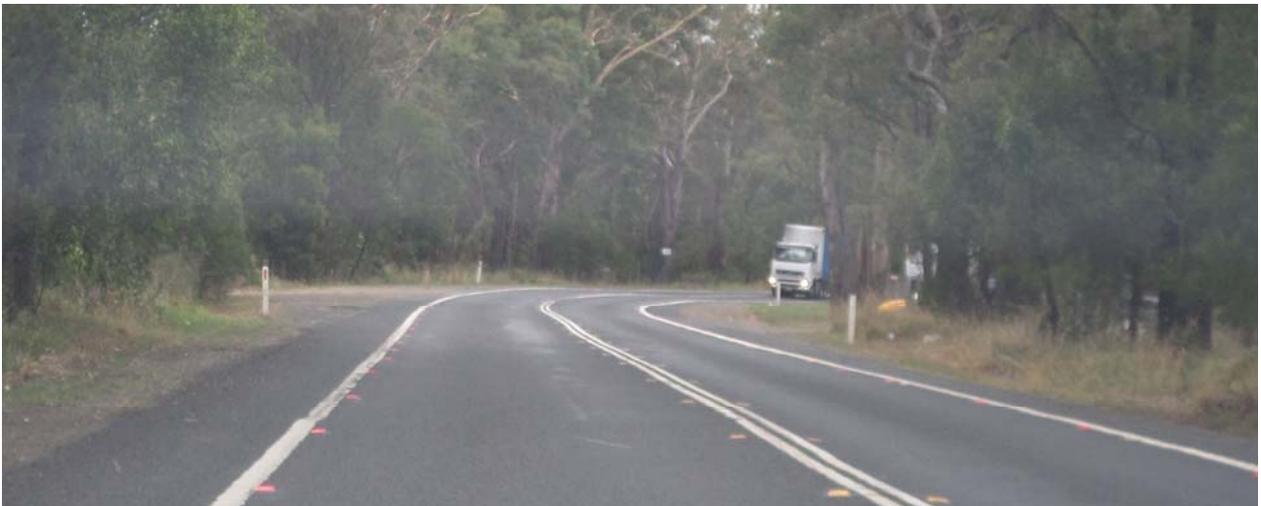
- Curve warning and advisory speed signs are to be reviewed for accuracy along the entire route, to ensure consistency along Appin Road. This review will also include the review of speed limit signs.

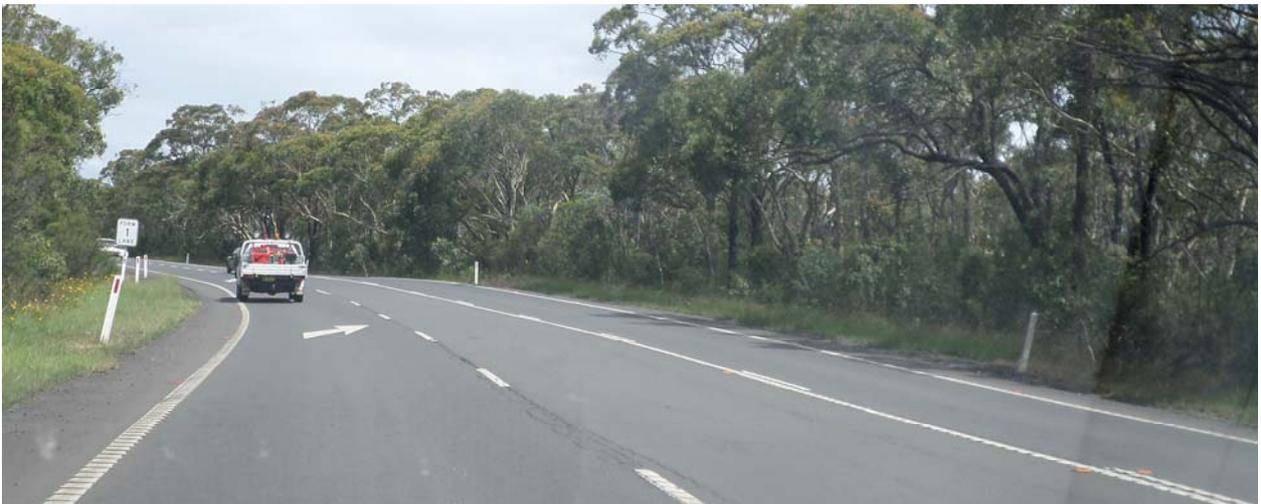
- Centre line marking along the route provides a number of short overtaking opportunities and some of these are adjacent to overtaking lanes and merges. A review of the centreline marking should be undertaken along the entire route.

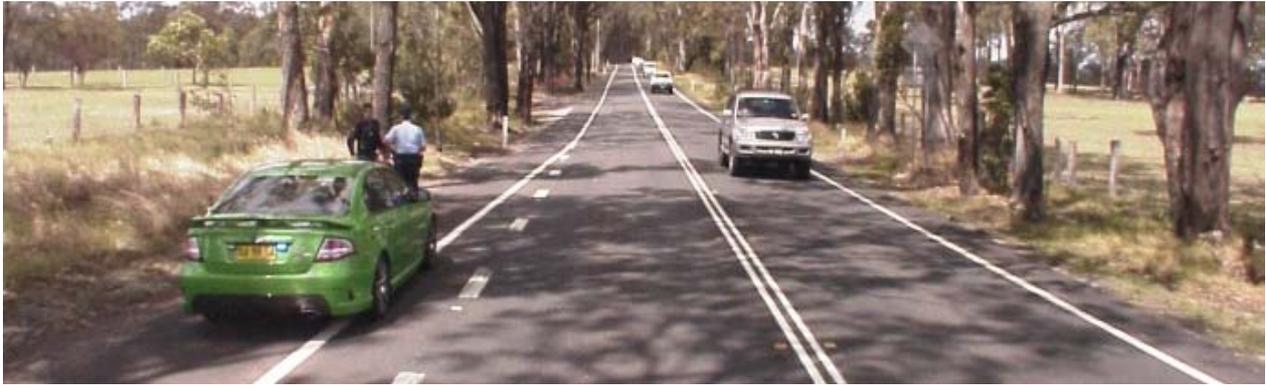
- Speed surveys have been collected along Appin Road which show that there is some non-compliance with the sign posted speed limits. NSW Police are responsible for the enforcement of the NSW Road Rules which include the enforcement of the speed limits and drink driving.

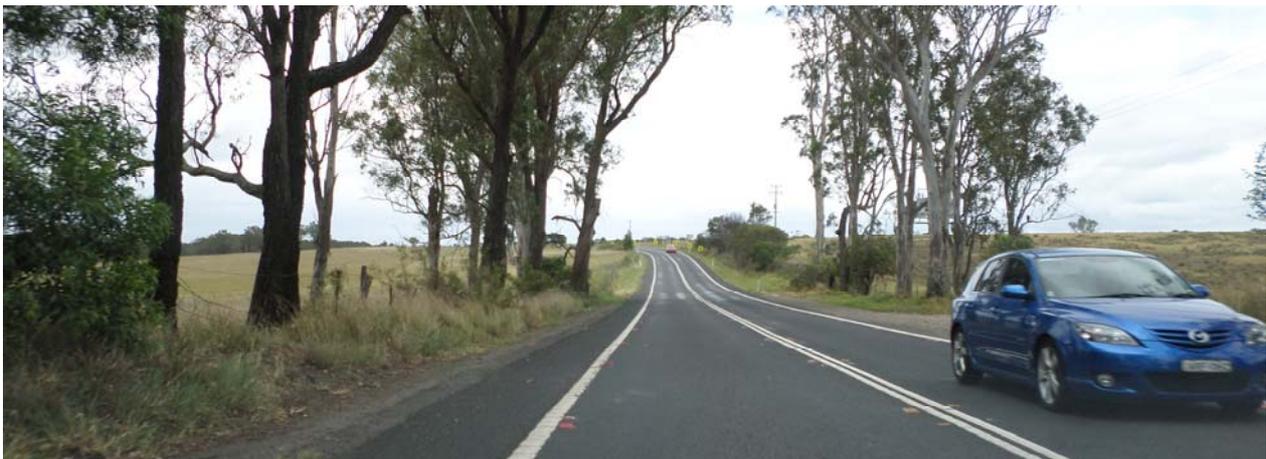
- There are very narrow sealed and often unsealed shoulders along much of this section of Appin Road. There is no opportunity to regain control of an errant vehicle in these narrow and predominantly unsealed shoulders. The lane widths in this area are around 3.5m, which are acceptable for this 80km/h speed limit.

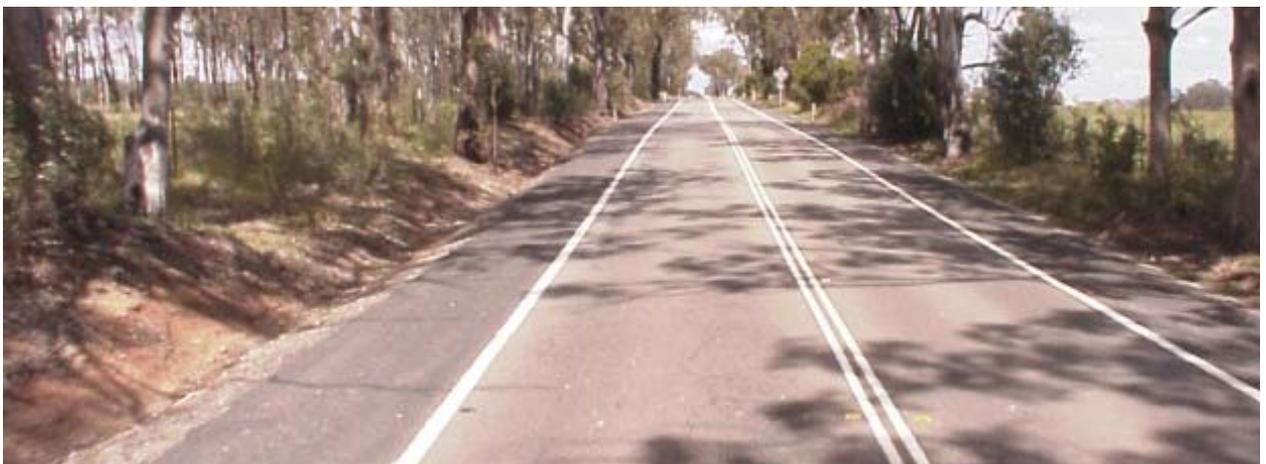
- Approximately 600m south of Kellerman Drive there are two sections of swale style drain that cover about 1km on the eastern side of Appin Road. This style of drain is in close proximity to the travel lane and poses a safety risk for errant vehicles.

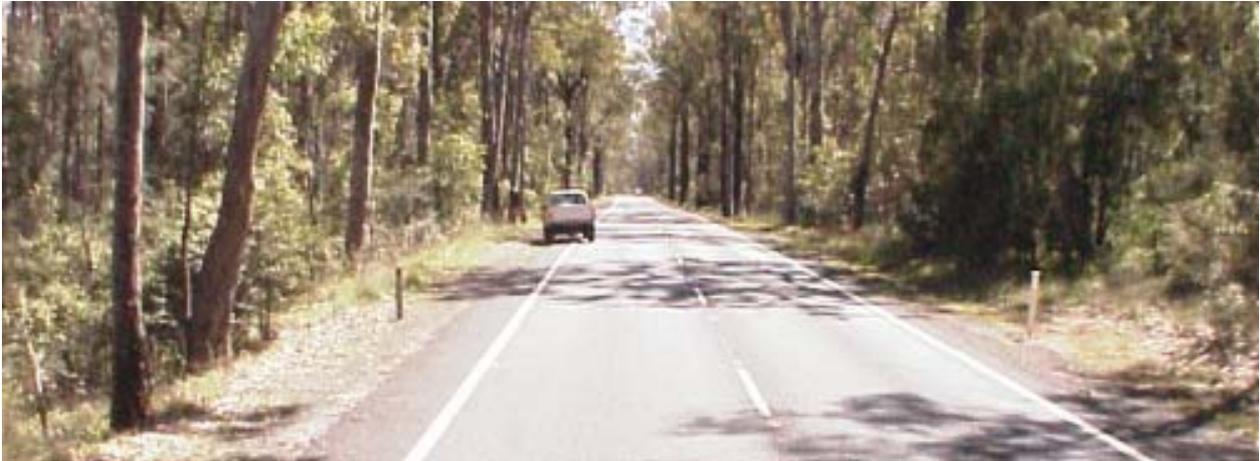
- Driveways to large rural residential properties line this length of Appin Road. Many of these driveways are concealed and there is a significant rear end crash history involving vehicles decelerating or stationary waiting to turn into these properties. Due to the narrow road configuration there is no opportunity to pass these slowing or stopped vehicles. As these rural residential houses are well set back from Appin Road it is likely road users do not expect to find propped or slower moving vehicles in this length of Appin Road.

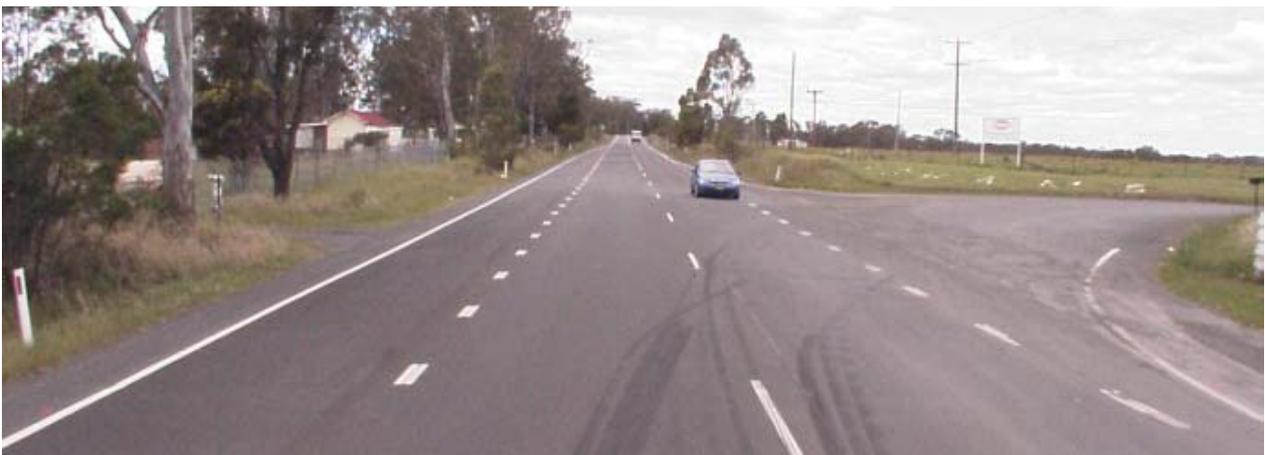
- A large commercial farm facility for Inghams Chickens is located on the western side of Appin Road. Access to this facility is provided at a large uncontrolled driveway access, to the north of Appin township. This intersection has only minimal signage and requires improvements to the line marking.

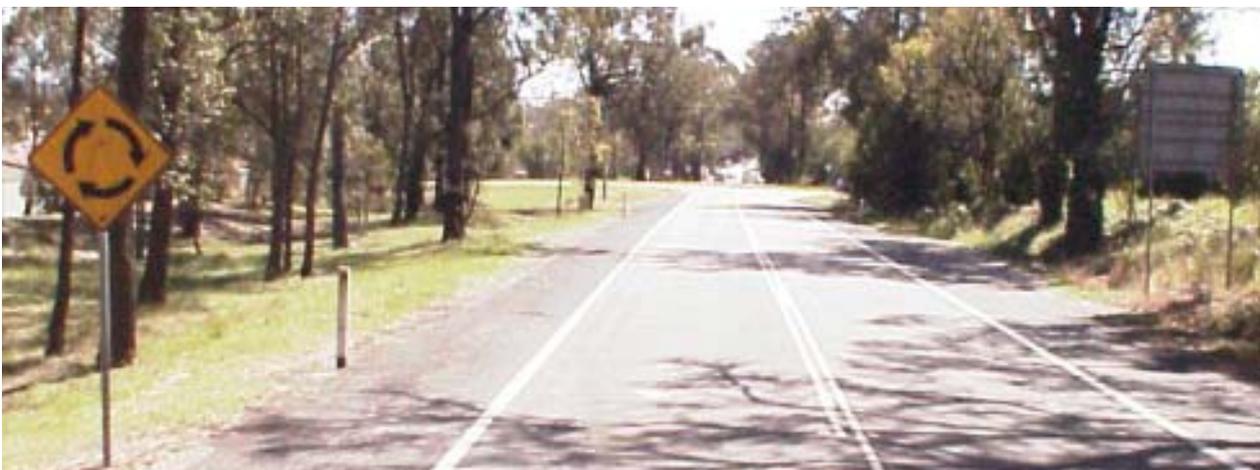
- There was a cluster of rear end collisions heading northbound on Appin Road on approach to the Kellerman Drive roundabout. There is no advance warning that you are approaching a roundabout or that there may be a queue of vehicles.

- Replacement of the non standard no right turn sign at Toggerai Street
- Replacement of the non standard hazard marker boards on the kerb extensions in front of Appin Public School.
- Advance roundabout ahead/reduce speed warning signs northbound on Appin Road approaching the Kellerman Drive roundabout
- Concealed driveway warning signage on the northern section of Appin Road.

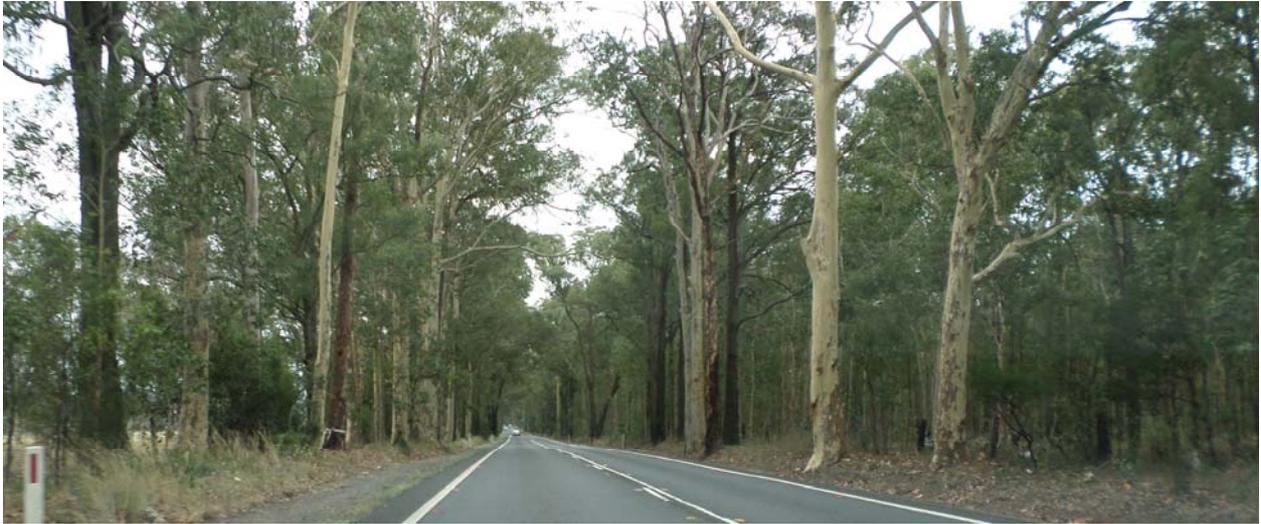
- Mature trees line much of this length of Appin Road and they are often located quite close to the travel lanes. In recent years two lengths of wire rope barrier were installed to protect errant vehicles from hitting some of these trees. Additionally profile edge lines and additional Raised Reflective Pavement Markers (RRPM) have been installed along the northern most 6km of this section to warn motorists if they leave their travel lane.

A detailed investigation of the clear zone along the northern section of Appin Road is currently being carried out by an independent consultant. An environmental assessment will need to be done as it is understood there may be an ecologically sensitive habitat in this area. If there are no environmental issues, then a hazard removal program will be developed in consultation with Council and the community.

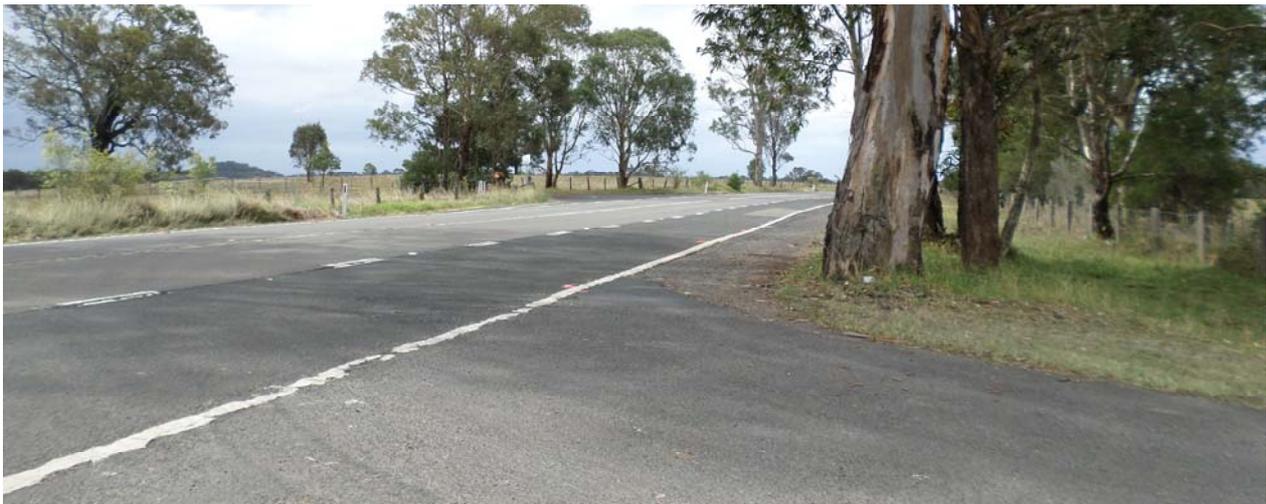
- A review of the driveway of 880 Appin Road has identified that the sight distance of approaching southbound vehicles, when turning onto Appin Road, was obscured by a large tree adjacent to Appin Road.

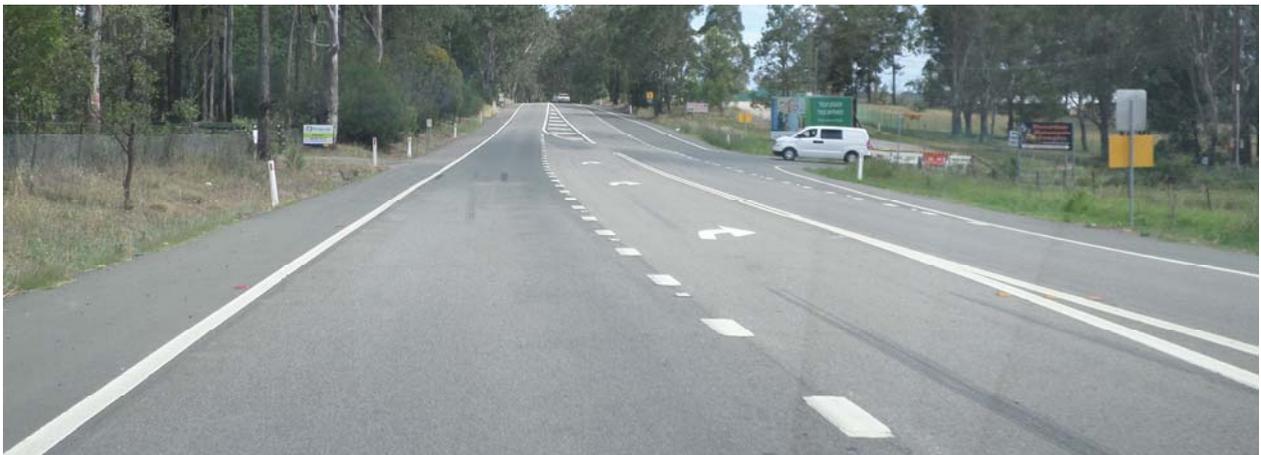
- Profile line marking is provided through much of this length of Appin Road, however there is a 3km section on approach to the Appin township that requires further investigation into the provision of profile edge and centre line markings.

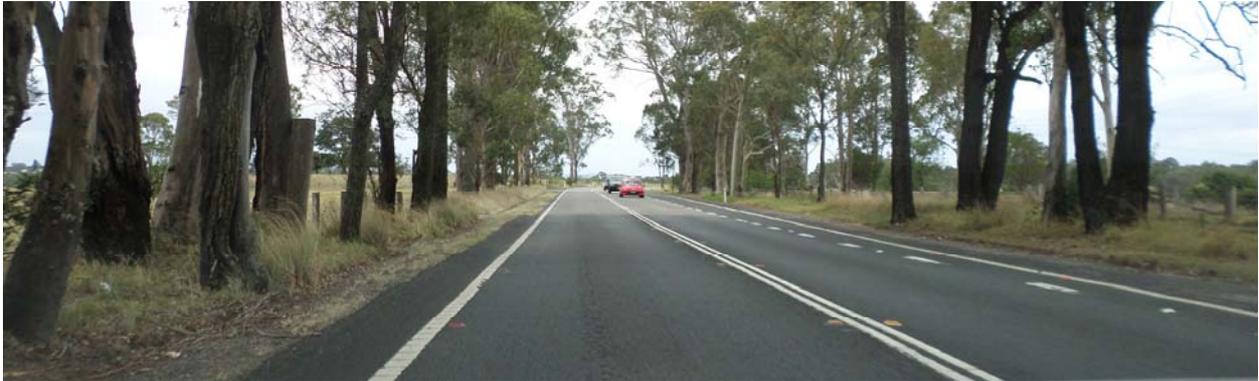
- As this is a rural section of road there is no street light provided, so at night road users rely on the line marking and delineation along the route, which includes RRPMs, centre and edge lines, guideposts and warning signs. During the daytime inspection the line marking generally appeared to be in a satisfactory condition, however further enhancement of the delineation, such as guideposts, should be considered.

Night time inspections will be undertaken to review the effectiveness of the existing signage and delineation along the length of Appin Road. Any deficiencies will be addressed.

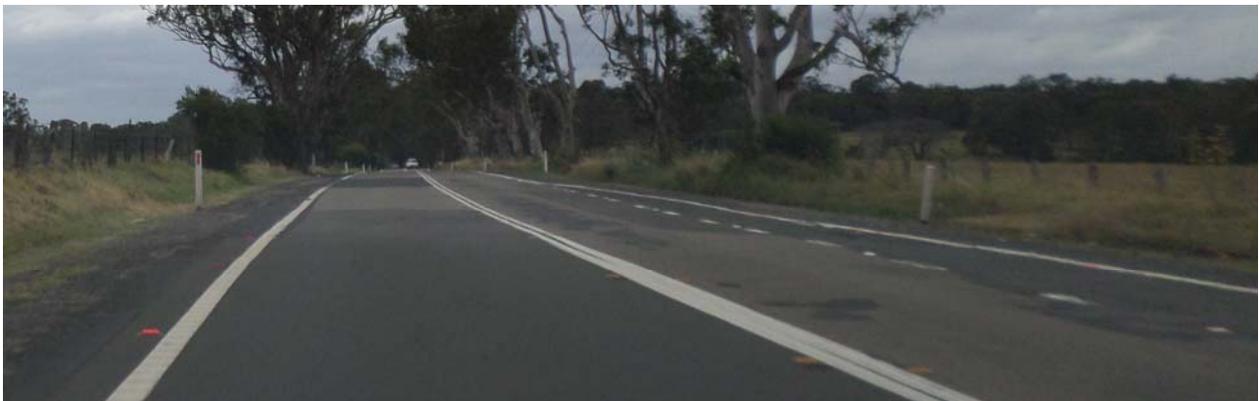
- There are a number of sections where the road surface has been heavily patched to repair potholes. As a result the ride quality is poor in some areas.

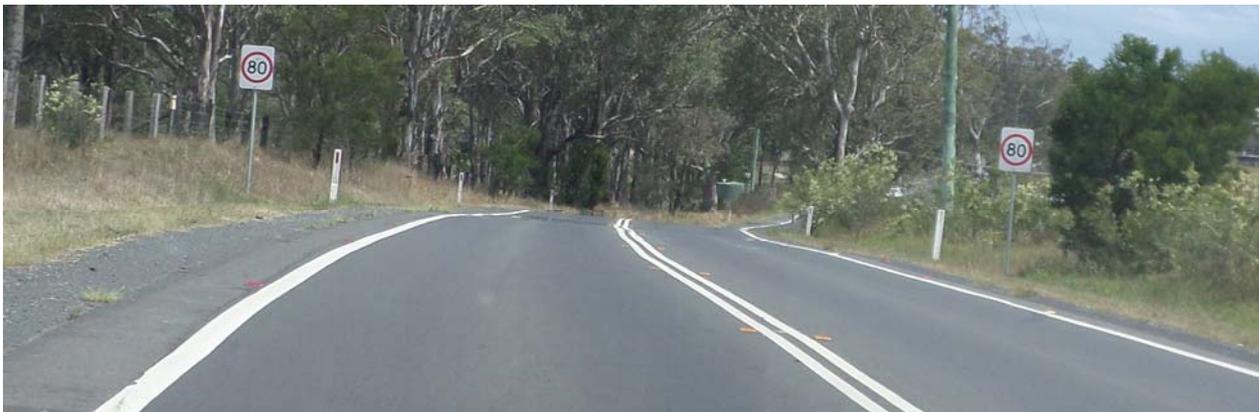
- Speed was noted as a factor in 10.9 per cent of the crashes along this length of Appin Road. The speed limit on the section of Appin Road to the north of Appin township was reduced from 100km/h to 80km/h in mid-2002 to reduce vehicle speeds and the incidence of crashes. The incidence of serious and fatal crashes has reduced significantly along this length of Appin Road post speed reduction. Although the NSW Police regularly enforce the speed limits on Appin Road, there is a need to investigate vehicle speeds in this area.

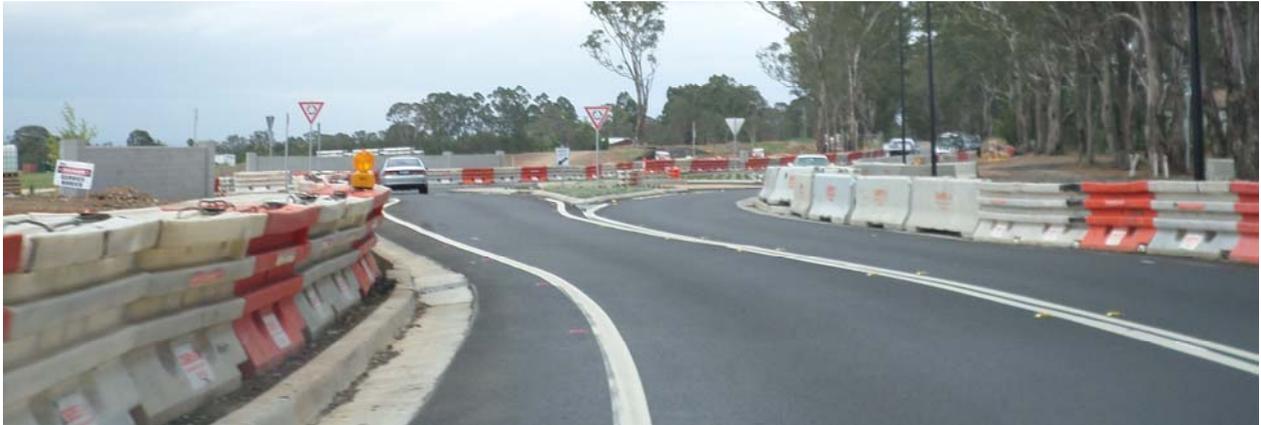
- A significant residential development is currently under construction adjacent to Appin Road on the northern outskirts of Appin township between Brian Road and Rixon Road. Access to this development is from a new roundabout on Appin Road which is being built. The speed limit in this area is currently 80km/h.

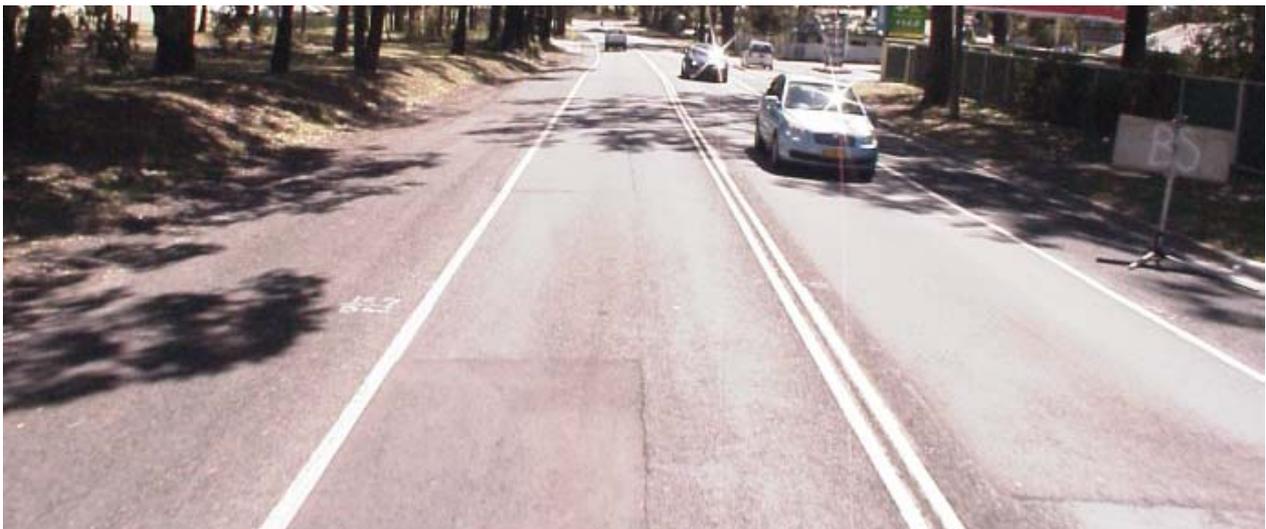
- Inconsistencies exist in the pavement through the Appin township due to the history of unrelated minor works and patching.

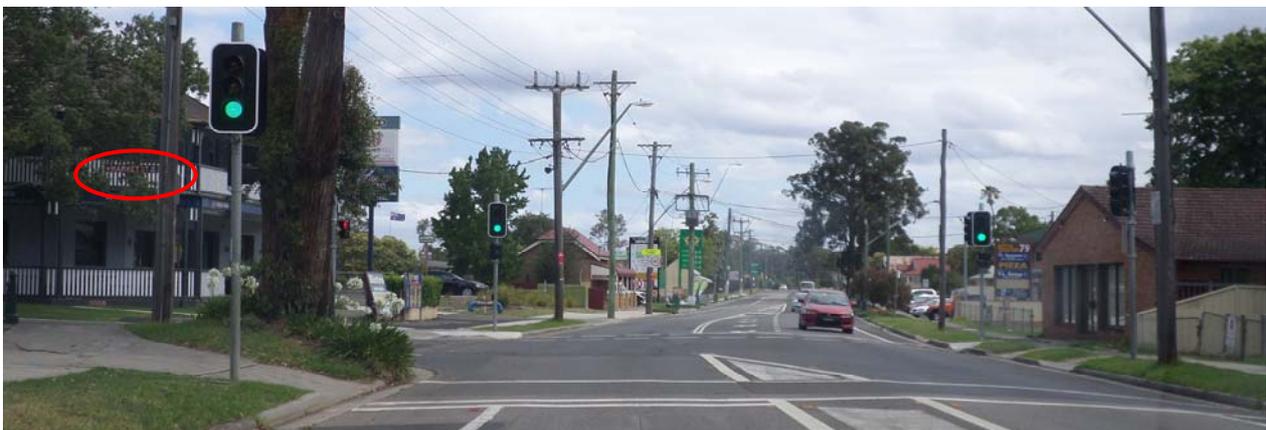
- Many of the local roads within the Appin township are poorly signposted. As this is the responsibility of Wollondilly Council it is appropriate to request Council to carry out a review.

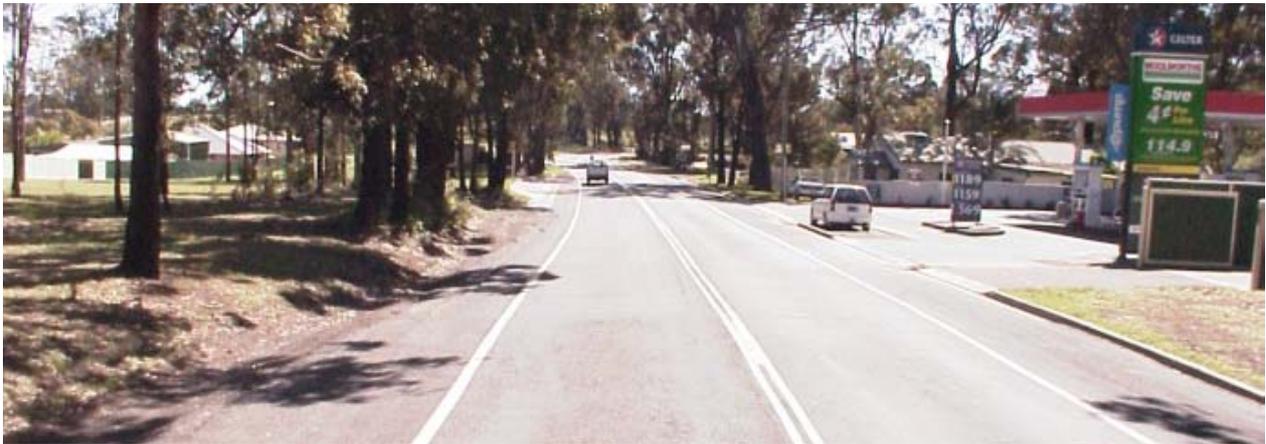
- There is a pinch point within the Appin township on Appin Road outside the petrol station (located on the eastern side). The entry and exit driveways are provided on to Appin Road adjacent to a stand of trees (which narrows the road shoulder) and an adjoining north and southbound pair of bus stops. There is a cluster of crashes in this area and the bus stops and the trees limit the opportunity to pass stopped or turning vehicles.

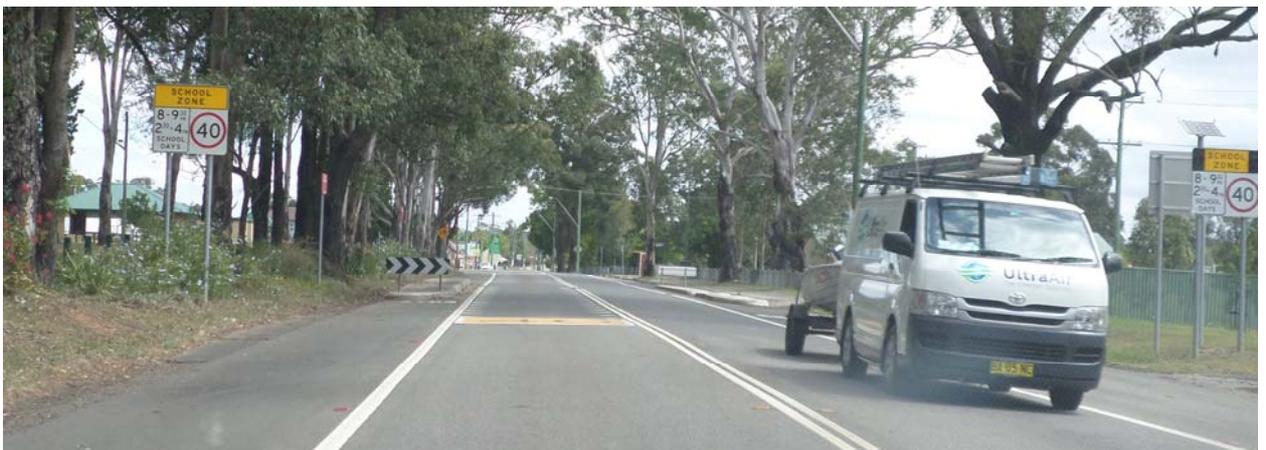
- A pair of kerb blisters were provided outside of Appin Public School to provide protection for pedestrians waiting to cross the road and to minimise the crossing length. The kerb blisters have an incorrect hazard marker board sign on both approaches.

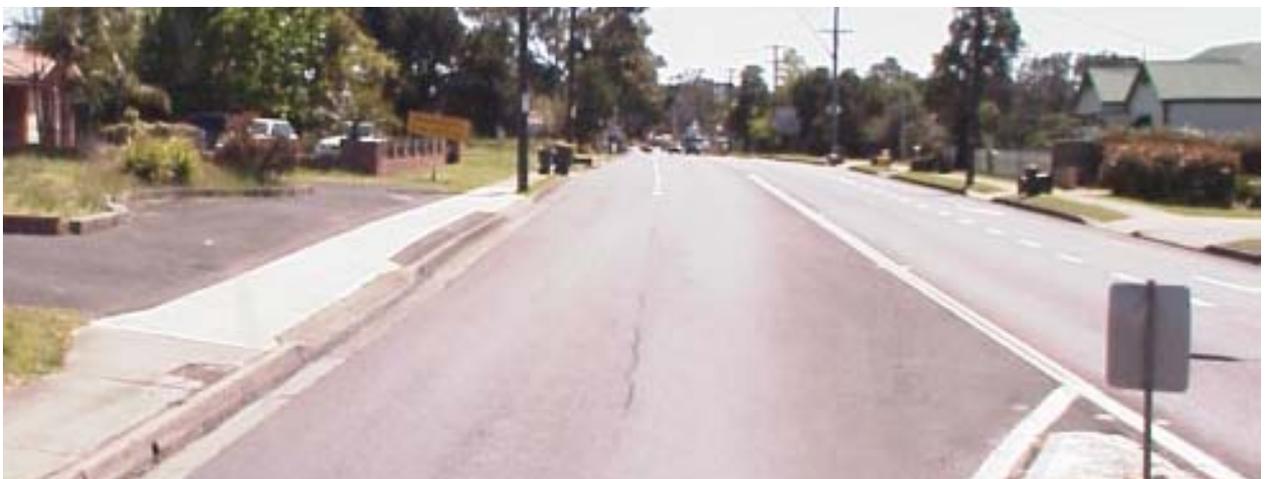
- Line marking at the intersection of Wilton Road and Appin Road (stop signs on Wilton Road only) is confusing, particularly the lane designation for northbound traffic on Appin Road. Further improvements to the delineation at this intersection and the approaches would further enhance safety at this site.

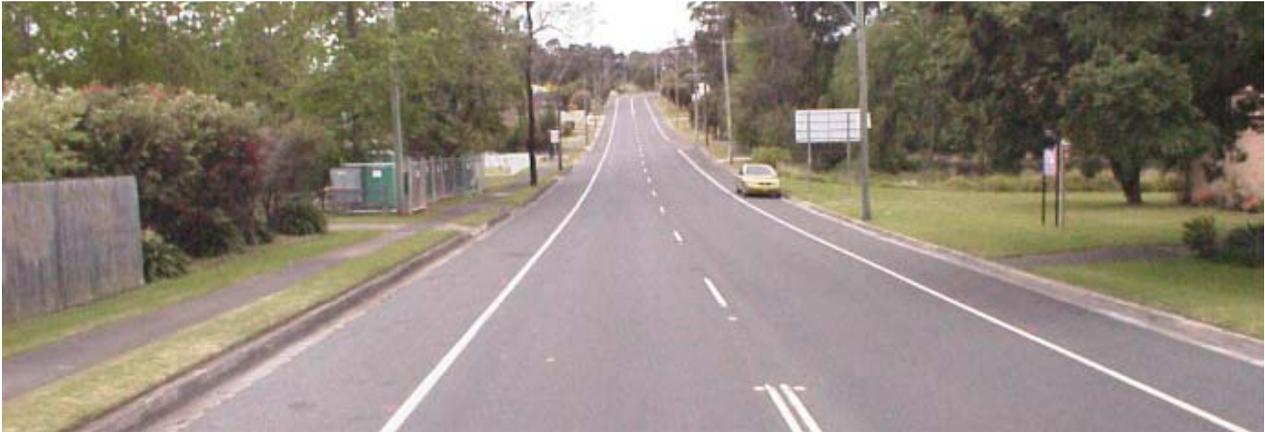
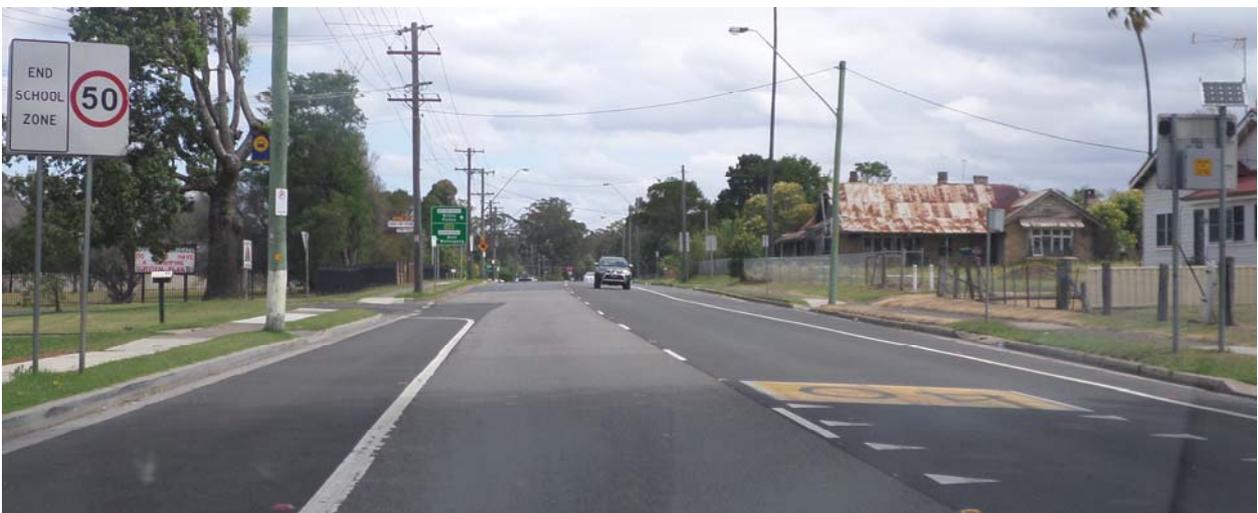
- Within the residential area there are two sections of overtaking permitted to the south and north of the Wilton Road junction. This overtaking falls within a 50km/h speed limit and may encourage unsafe manoeuvres adjacent to residential properties and near the school.

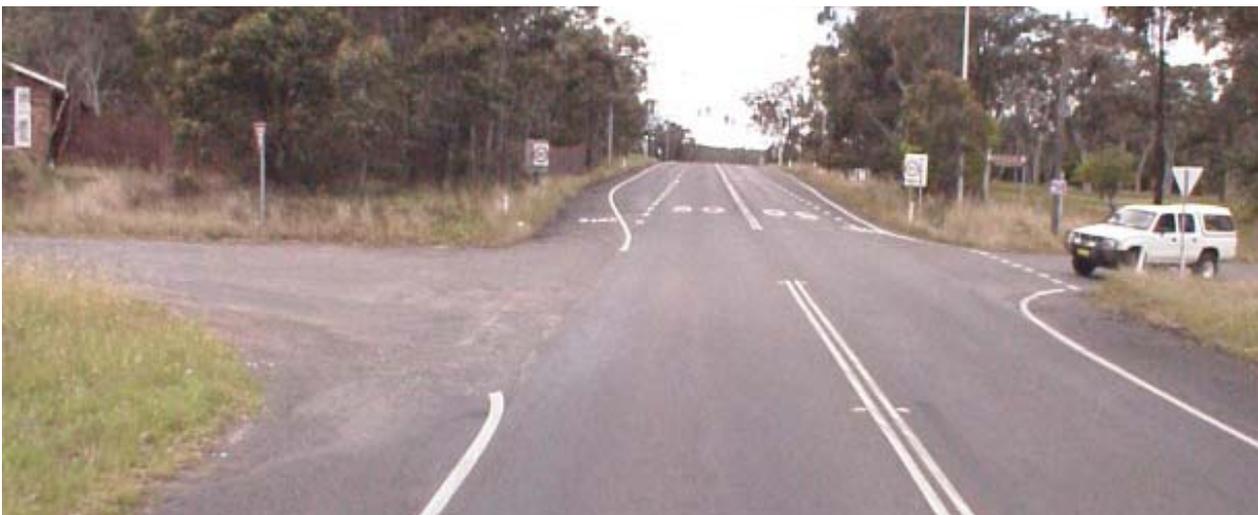
- The intersection of Illawarra Street (northern leg) at Appin Road is currently unsealed (gravel). As a result the gravel has been pulled into the intersection. Additionally the line marking at this intersection is poor and the creation of the two southbound lanes on Appin Road occurs immediately after this intersection.

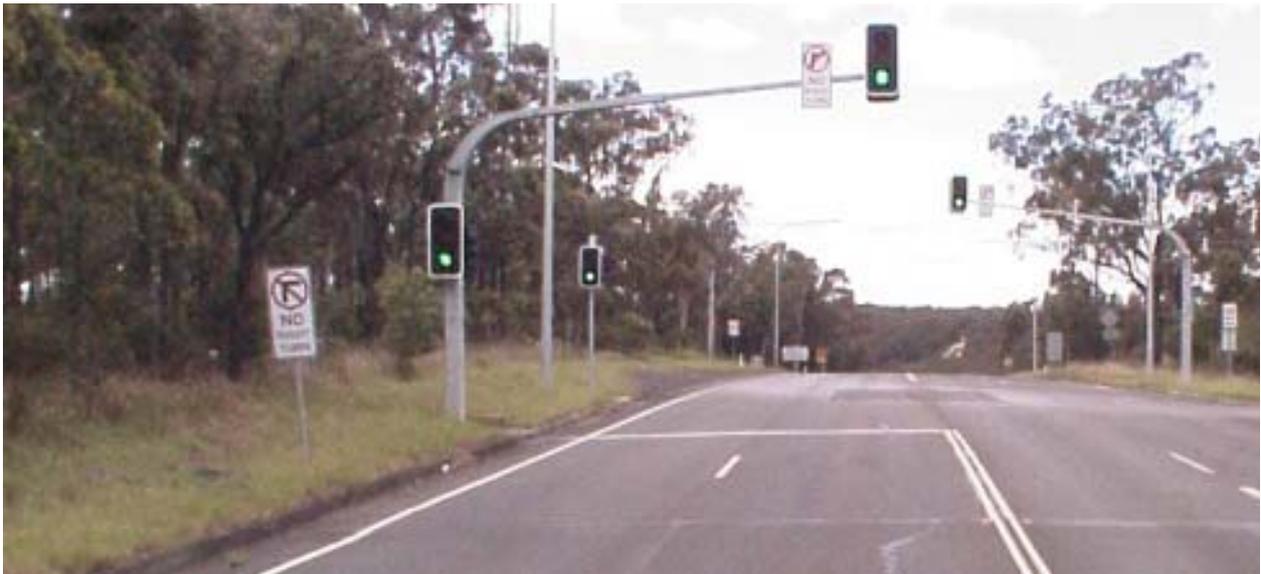
- A non-standard 'No Right Turn' sign is incorrectly installed on Appin Road southbound at the Toggerai Street intersection.

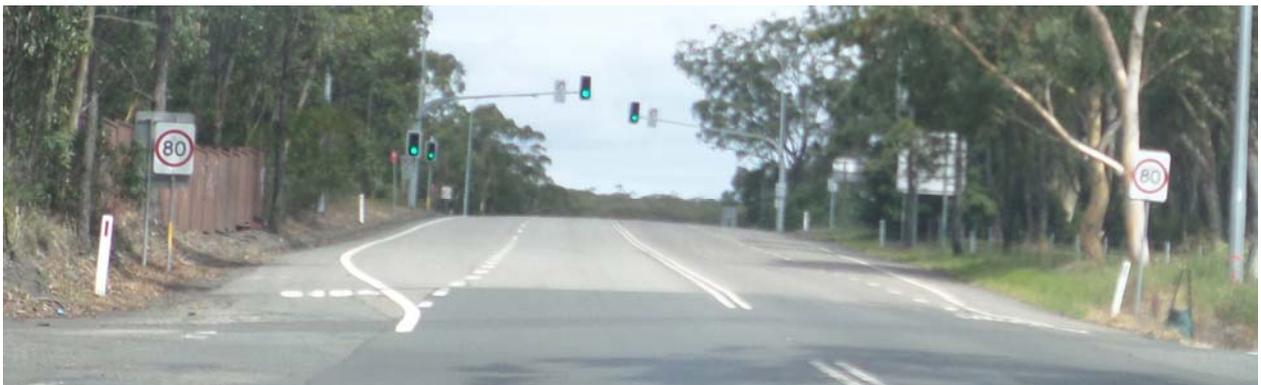
- Currently the 80km/h speed limit on the southern outskirts of Appin township starts 120m north of the traffic signals at Toggerai Street resulting in vehicles accelerating on the southbound approach to an intersection with traffic lights. In this area there is also a short merging lane for northbound traffic within an 80km/h zone.

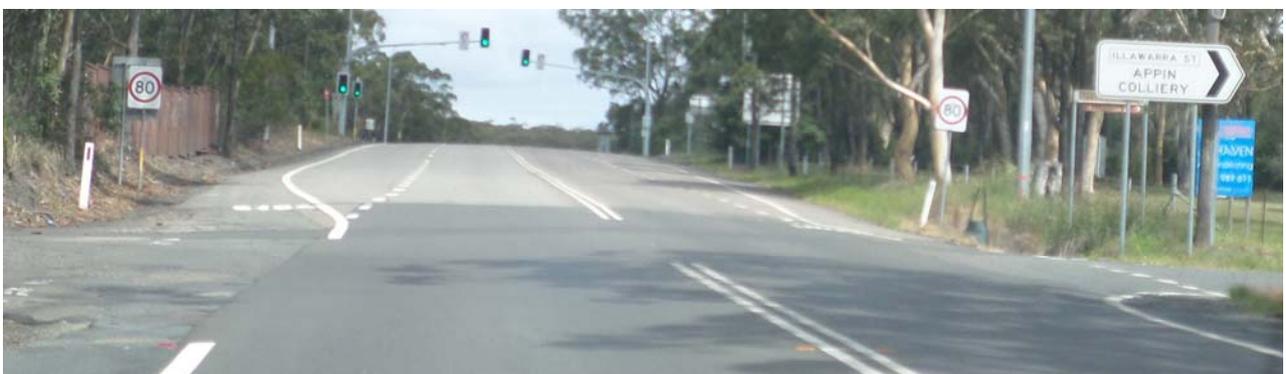
- A southbound overtaking lane starts just before the intersection with Toggerai Street which has traffic lights and this encourages road users to accelerate approaching intersection. Additionally the overtaking lane is on the left hand side of the approach lane, which is not standard as it promotes road users to undertake turning vehicles.

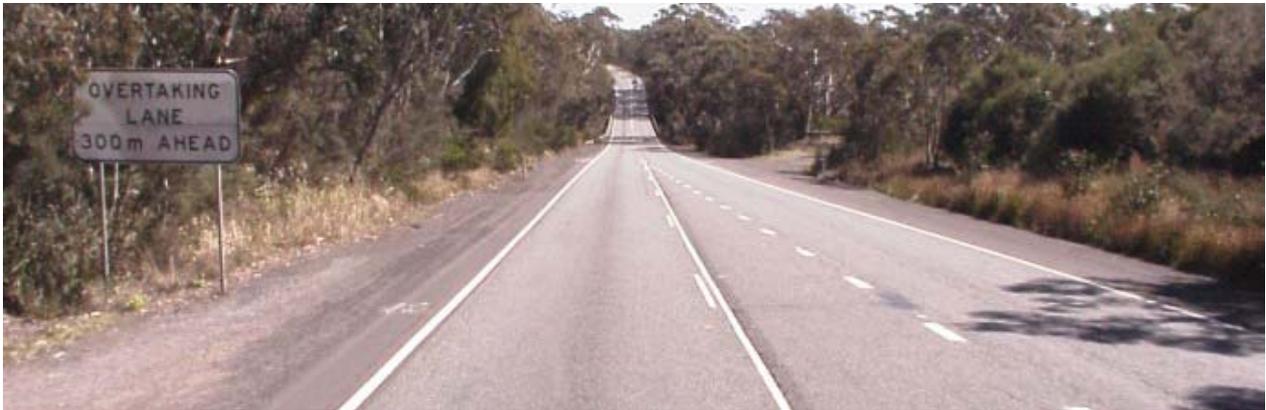
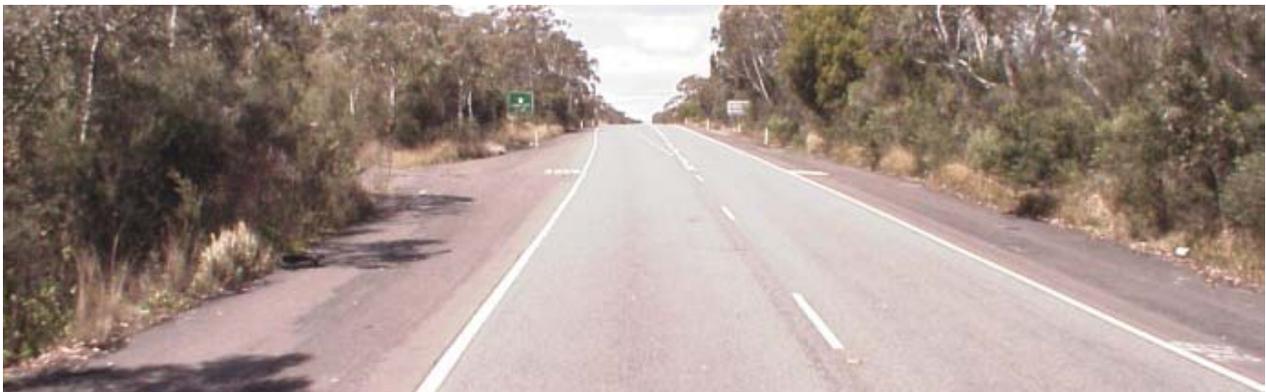
- In 2012 on the approaches to Loddons Creek Bridge two sections of overtaking opportunity (370m southbound and 1.3km northbound) were identified on Appin Road in close proximity to overtaking lanes. Overtaking lanes provide a safer environment.
