**APPIN ROAD
KELLERMAN DRIVE TO PRINCES HIGHWAY**

ROAD SAFETY INVESTIGATION REPORT

MARCH 2014

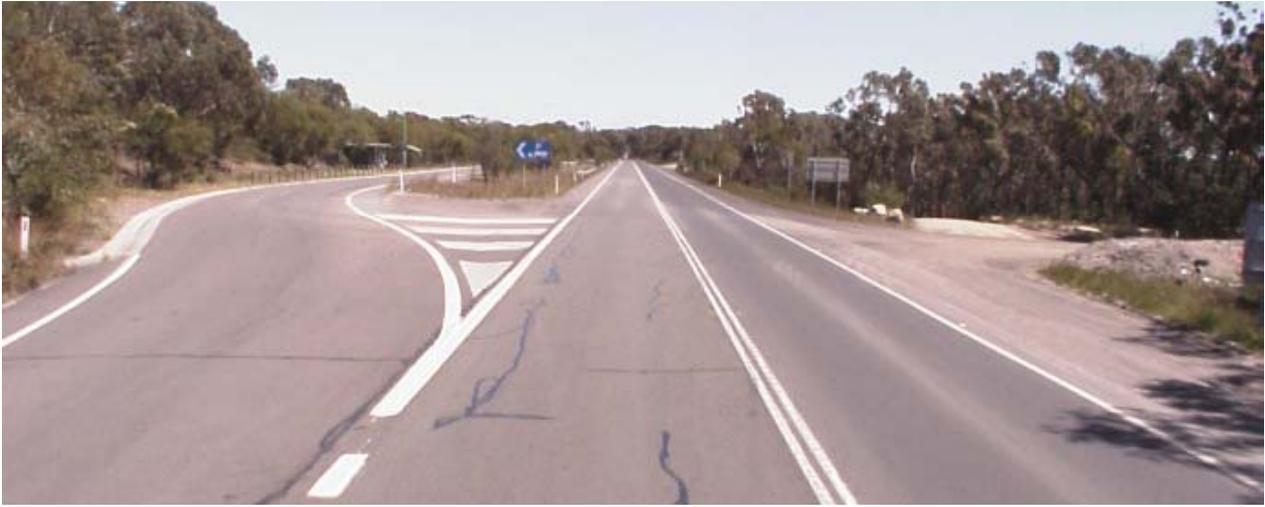
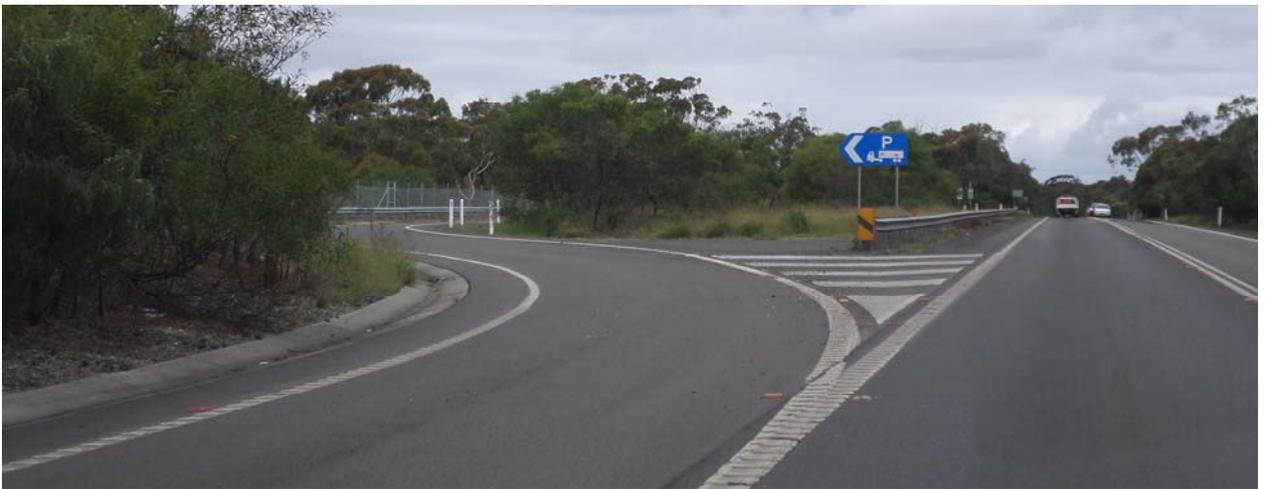
- Eastbound and westbound combined rest areas for light and heavy vehicles are provided along this length of Appin Road to manage driver fatigue and provide an opportunity for a rest break. Roads and Maritime is currently investigating the placement of mobile vendors in these rest areas. It is expected that mobile vending in rest areas will increase the number of road users stopping at this facility and may reduce the incidence of fatigue related crashes.

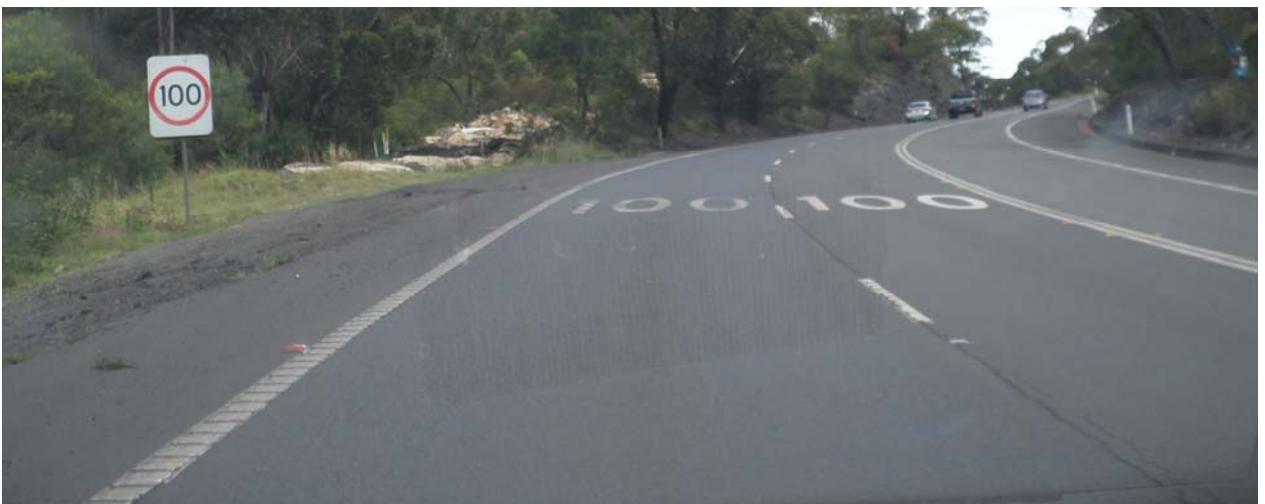
- Around the exit from the West Cliff and Appin colliery's there is a visible impact of coal dust falling on the road from vehicles. The line marking in this area is grey in colour and appears quite dull. The effect of coal on the road and line marking needs to be better understood.

Roads and Maritime will hold a discussion with the colliery regarding the coal dust, which accumulates on the road surface and line marking along Appin Road. During inspections it was also noted that coal from vehicles was deposited in the rest areas.

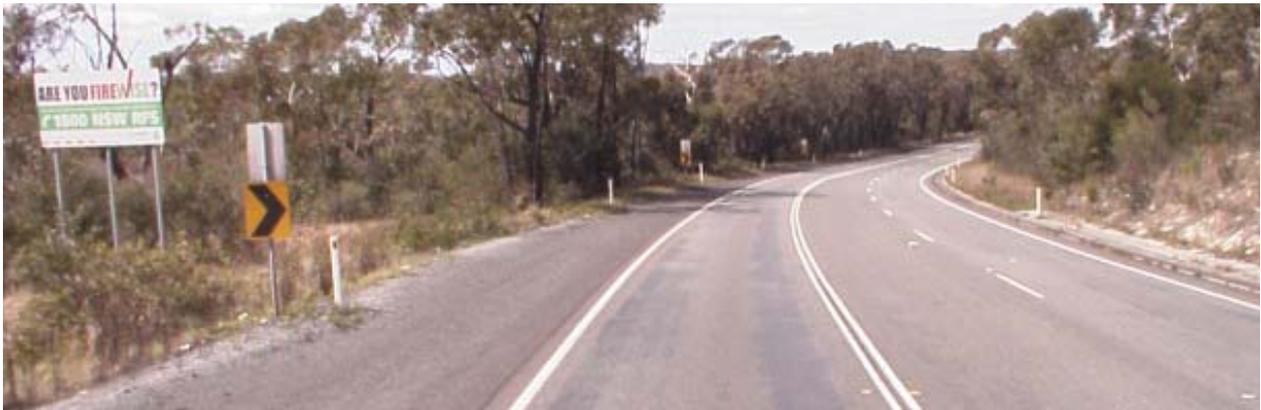
- A Firewise advertising billboard is located facing southbound traffic on approach to the bend near crash cluster four. A driver's attention should be focussed on the driving task at this point in time and not on reading a billboard sign.

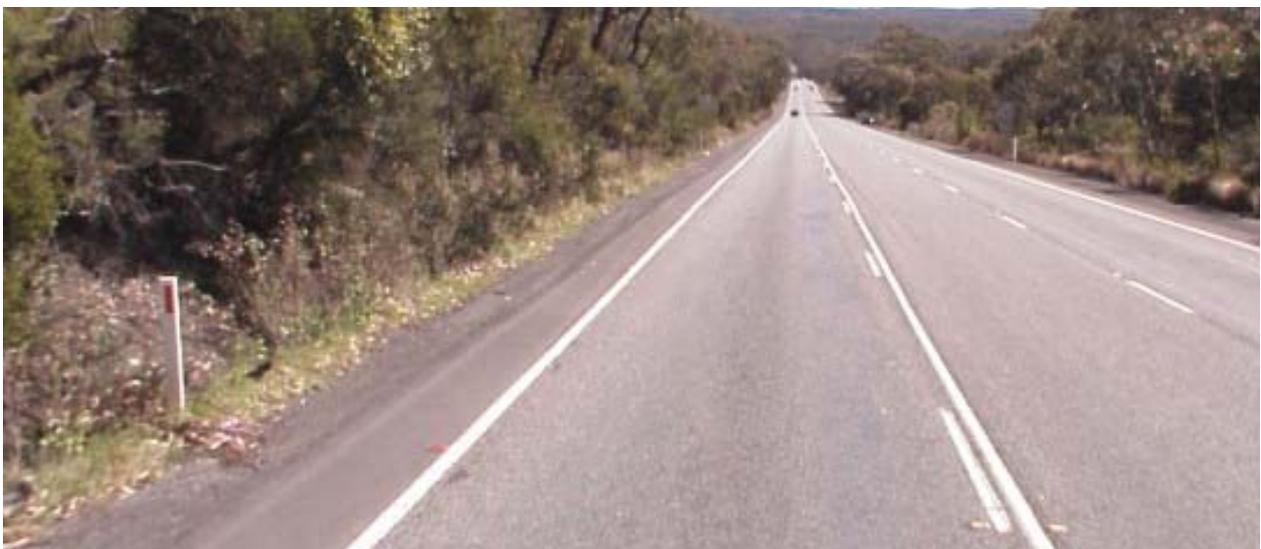
- The safety review suggested the use of vehicle activated signs (VAS) around crash cluster four. VAS are most effectively used to warn drivers of a specific hazard, rather than a length of road, and so would not appear to be warranted in this location. A review of the curve advisory markers, curve warning and advisory speed signs is planned to be undertaken.
- At the southern end of Appin Road there is a large and very deep drain on the western side of Appin Road, set back around three to five metres from the travel lanes. This unprotected drainage channel may pose a hazard for errant motorists.

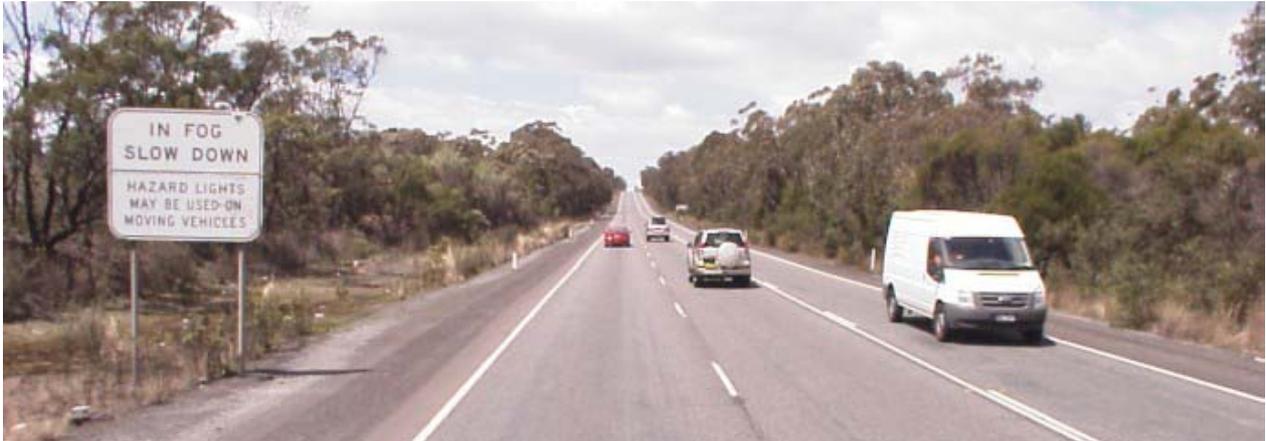
- The analysis indicated that four crashes occurred during fog or misty conditions. As with a number of roads in this area at the top of the escarpment the weather conditions can change quickly and a heavy fog or mist may restrict a driver's visibility. Signage is provided to warn motorists.

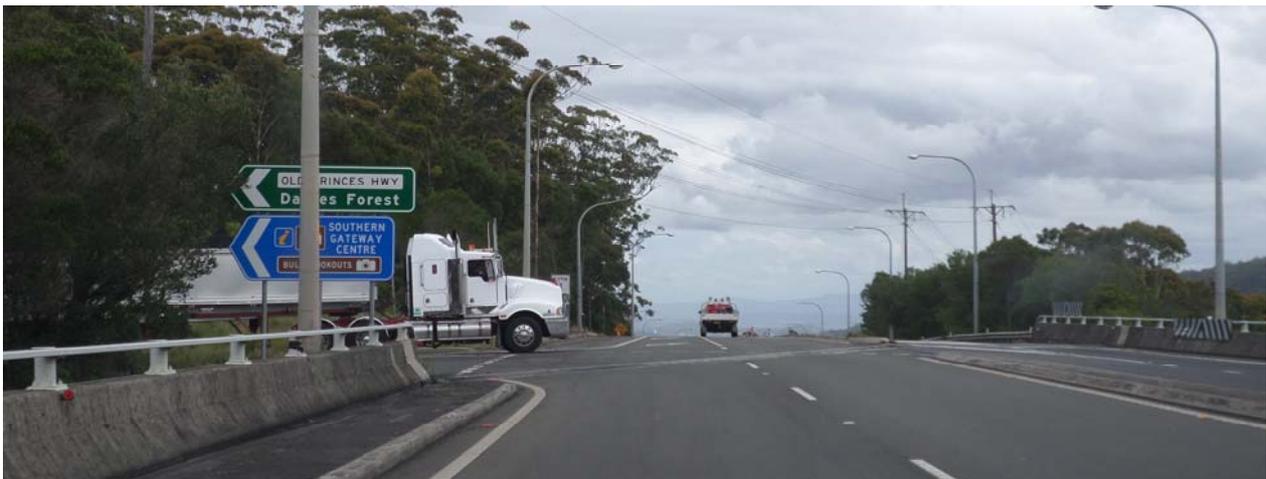
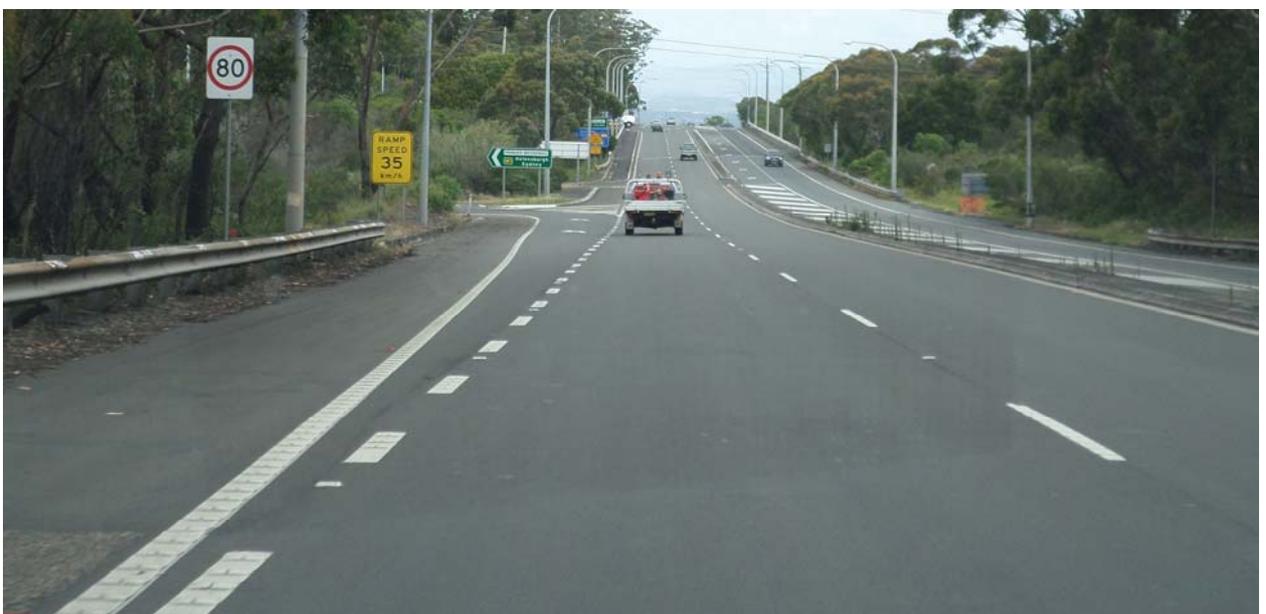
- There were eight reported crashes at the intersection of Appin Road and Princes Motorway. Four of these were right turn/through traffic crashes which involved vehicles crossing two southbound lanes on Appin Road to make a right turn. A further detailed review of sight distance and vehicle manoeuvres at this intersection should be looked at, with consideration of a single southbound lane through this intersection and the addition of left turn lanes. A short merge is provided on the southern side of this intersection.
